Unidentified Harbor Wreck  
*Royal Navy Dockyard, Bermuda*

**Report of Fieldwork  
December 2007**

Nathan Richards  
Joseph C. Hoyt  
*Program in Maritime Studies  
East Carolina University  
Greenville, North Carolina, USA*

*Report to the  
Government of Bermuda &  
Bermuda Maritime Museum  
February 2008*

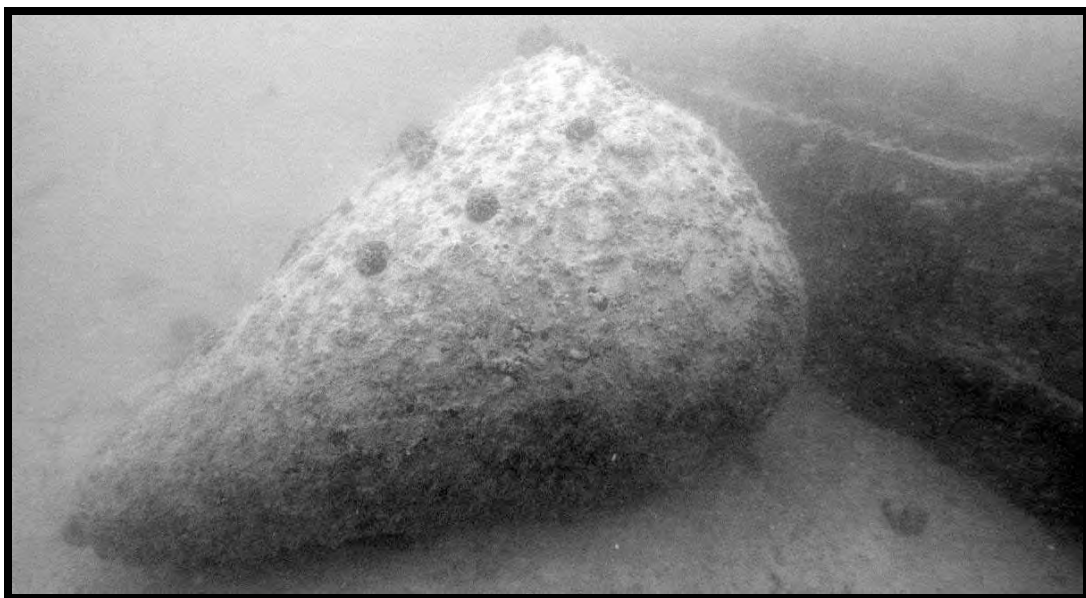
This gives the vessel a minimum draft of 8.2 feet (2.5 m) from deck-level to keel. In all likelihood the draft might be another foot or so to the base of the keel giving an estimated distance from deck to keel of around 9 feet. This is in line with other documented drafts for vessels known as "steam lighters" (to be discussed). The wreck site is oriented at around 27.9° degrees west of magnetic north, or 332° magnetic. A large navigation buoy sits a few feet off bow and adjacent to the starboard side (Figure 7). The buoy has a maximum length of around 11.5 feet (3.51 m) and a base diameter of around 7.9 feet (2.41 m).

**Figure 7.** Navigation buoy (Photo: J. Hoyt, 16 December, 2007).

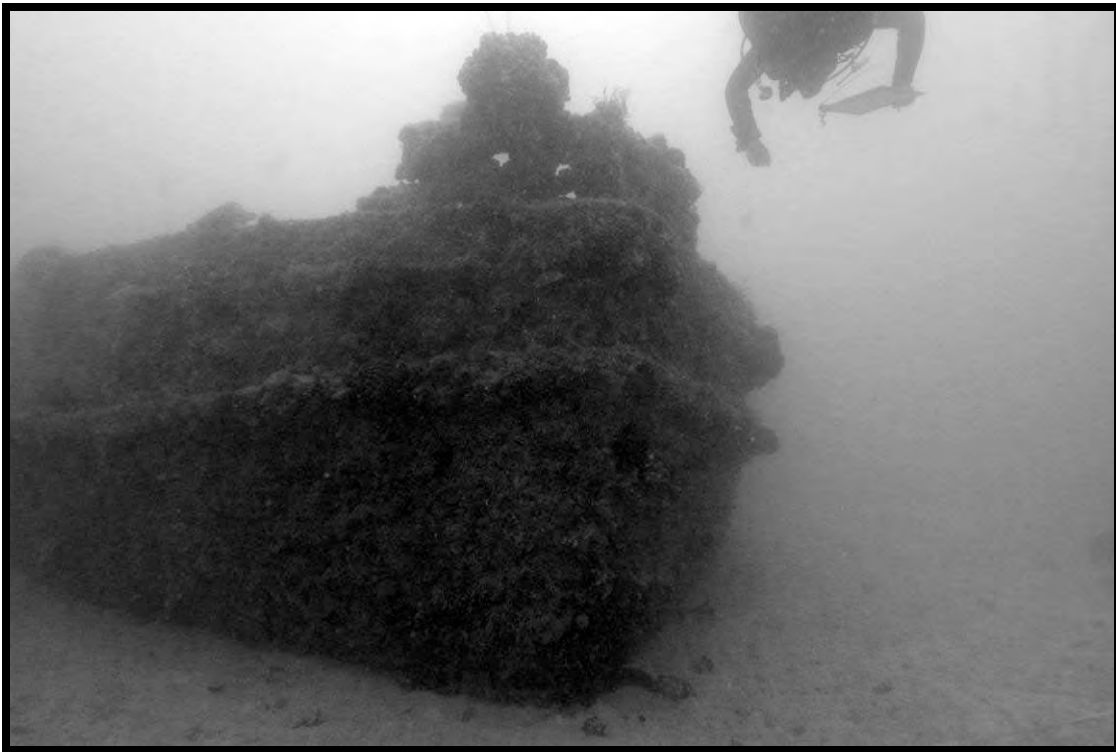
There are, however a number of deck features in situ. Along the centerline of the bow of the vessel there are fairleads, the remains of a windlass or winch (4.8 feet or 1.46 m from the bow), and a mast carling (12.2 feet or 3.72 m from the bow). The port and starboard sides of the ship sport cleats (10.8 feet or 3.29 m from bow). In the midships section a horizontal pipe with spigot run longitudinally along the port side. Towards the end of the internal compartments, there is a large turntable with "spindle." In the bow section two ladders can be seen about 13 feet (3.96 m) from the stern. At the extreme end of the stern the rudder and tiller are still extant. Around the hull remnant fenders once encircled the ship, but are now most obvious at the bow and stern (Figure 8).

**Figure 8.** Fenders attached to the bow of the wreck (Photo: J. Hoyt, 16 December, 2007).

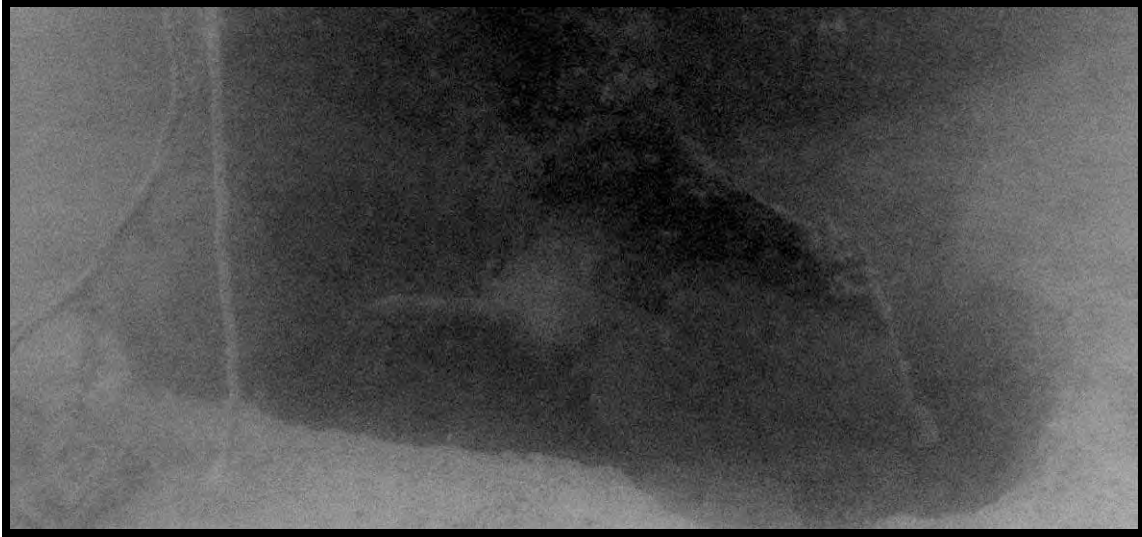
There is no noticeable damage to the outside of the hull plating or to any of the deck beams. Outside of the hull, the only damage noticeable are missing sections of fender (especially the starboard side) and extensive damage (twisting) to the rudder which is bent over considerably to starboard (Figure 9).

**Figure 9.** Stern of the wreck site showing excavated area in addition to the in site propeller and turned rudder (Photo: J. Hoyt, 18 December, 2007).

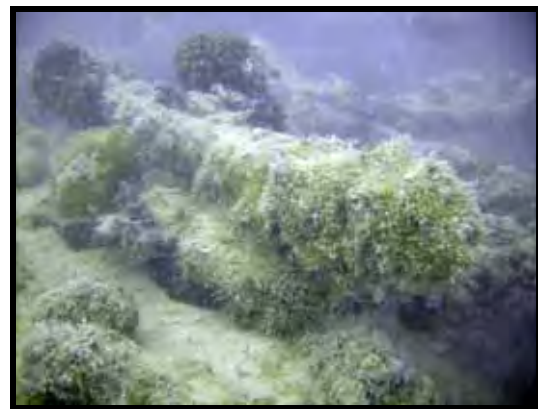
**Figure 11.** One of the bow cleats on the unidentified Bermuda vessel (Photo: N. Richards, August 1997)

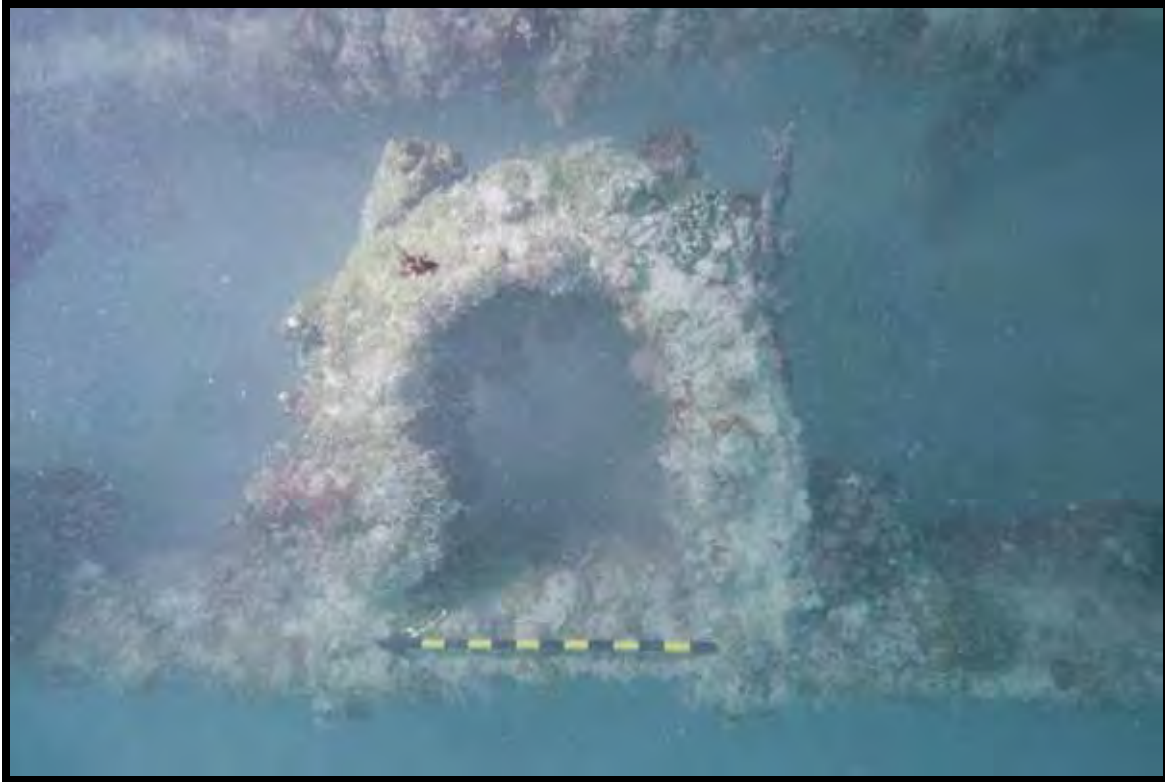
This does not indicate that the vessel was masted and rigged. More likely the ship has a pole mast which would have been setup as a derrick. The pole mast would have been mounted on the deck, with this sturdy ferrous “horseshoe” providing extra stability and strength (had the deck been iron or steel, there would have likely been a mast partner plate).

**Figure 13.** Detail photograph of the mast partner (scale in inches) (Photo: J. Hoyt, December 2007).

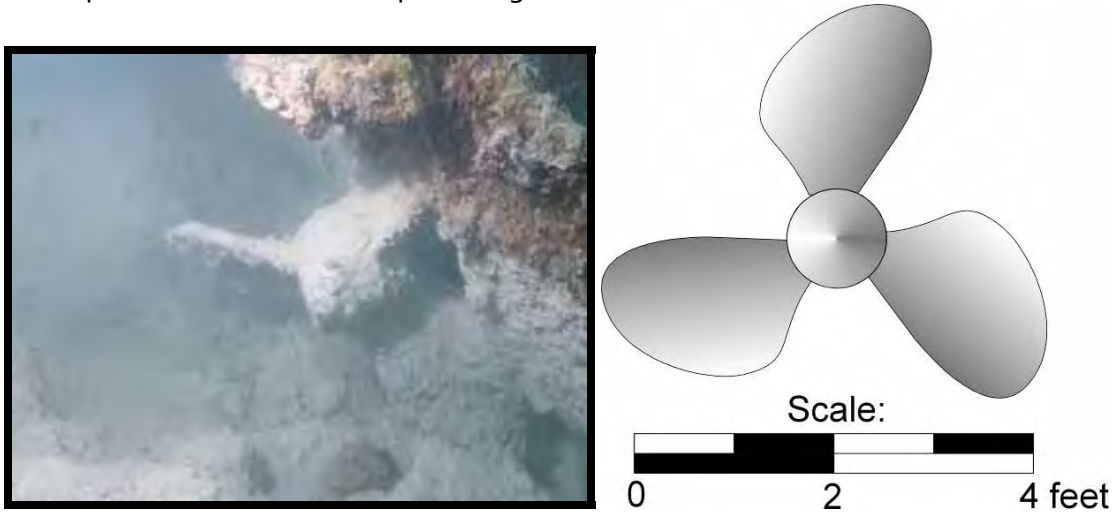
One last piece of information from Seaton notes that the first patent for blades with curvature was by Herman Hirsch in 1860 (Seaton 1908: 29-30). All the evidence corresponds with a vessel not predating the last few decades of the nineteenth-century.

**Figure 14.** Photograph and scaled sketch of propeller (Photo: J. Hoyt, Drawing: N. Richards).

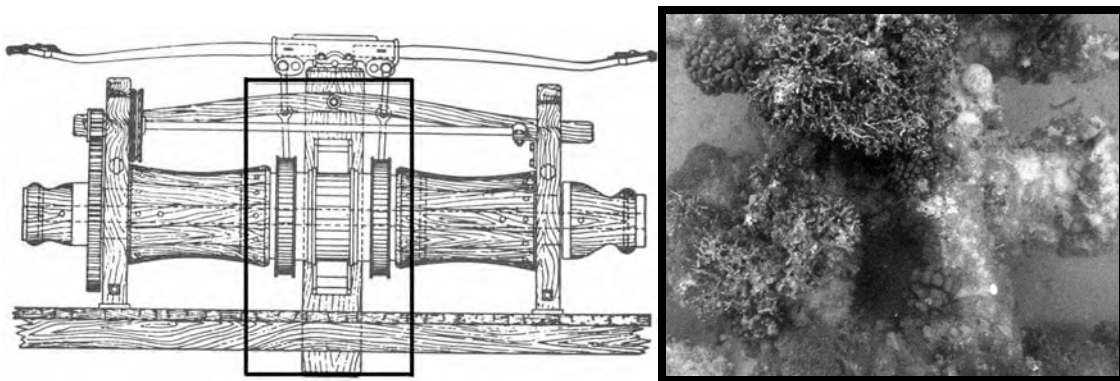
*Bow windlass remnant:* The partial remains of a windlass can be seen in the bow of the vessel. The windlass appears to only be a remnant with much of the apparatus, such as the warping drums missing (presumably removed).

**Figure 15.** Windlass with gearing for a messenger chain system (left). Box inserted by authors to show areas still extant on the wreck site. Photograph of remnant bow windlass (right) (Reproduced from Russell 2005: 131; Photo: J. Hoyt 16 December, 2007)

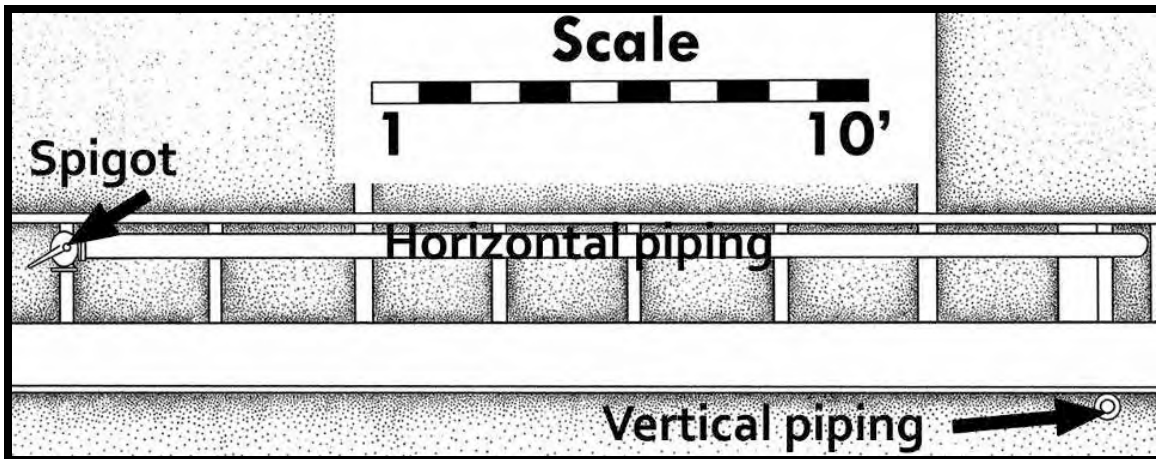
*Pipes and spigot:* On the port side of the vessel, there are two pieces of piping. One of these pipes runs horizontally in the center of the vessel for about 22 feet (6.71 m), terminating in a spigot or tap at the bow-end. Another pipe runs vertically in line with the stern end of the horizontal pipe down into the sediment (at least 5.2 feet or 1.58 m). The function of either of these pipes is currently unknown. The best guesses regarding their function relate to their use in the transfer of water, fuel or other liquid cargos between ship and shore, or between ships.

**Figure 16.** Plan view detail of piping along the portside of the wreck site (Drawing: N. Richards, J. Hoyt, B. Rodgers).

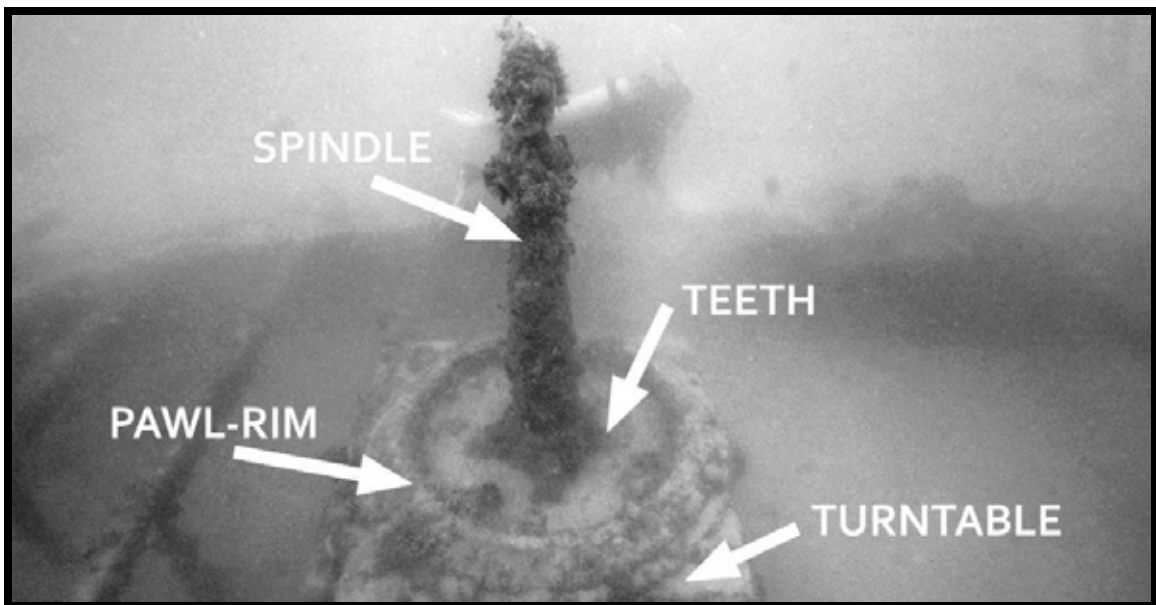
*Unidentified Object: "Spindle" and "Turntable":* One of the most visible features on the site is a large object that came to be known as the "spindle" (Figure 17). This object is made up of a number of pieces. Because the authors cannot currently confirm the actual use of the object with absolute certainty we have opted to create terminology in order to make description easier. The object is made up of a number of components – the "turntable," measuring about 5.4 feet (1.65 m) square, a "pawl-rim," a series of circles covering the turntable, a "spindle," of diameter 1-inch (2.5 cm) and extending 5.9 feet (1.8 m) above the turntable, and "teeth" (0.2 by 0.2 feet), which sit at the base of the spindle within the pawl-rim and on top of the turntable.

**Figure 17.** Detail of the "spindle" and "turntable" showing terminology created for this discussion (Photo: J. Hoyt, 16 December 2007).

Doubts emerge if we consider the large size of the spindle (almost 6 feet high), and the likelihood that this, being at the stern of the vessel would have been covered by a deck-house.

The remnant “spindle” should be cut down to as close as possible to the “turntable” attached to the wreck. This will give cruise liners the additional approximately 6 feet (1.83 m) needed to ensure that they do not come into contact with the ship. As noted before this will give the vessels at least 16-18 feet of clearance above the wreck. Because the spindle appears to be a critical feature for the potential identification of the site, it is recommended that the iron remnant be given to an agency for de-concreting and analysis to determine its function, and help add to information regarding identity. Additionally, it would be prudent to inspect the vessel annually to examine the impact scour from liner propeller wash and/or an increase in sedimentation within the hull has on the wreck’s stability and preservation. Should inspection suggest that the vessel is being undermined (i.e. it is shifting or listing), recommendation 2 may be warranted. The removal of the spindle and some monitoring is also a low-cost option, and should be easy to carry out.
