Investigation of 22 landslides in Upper Chase Creek, B.C.

Bill Grainger

Grainger and Associates Consulting Limited, Vancouver, B.C.

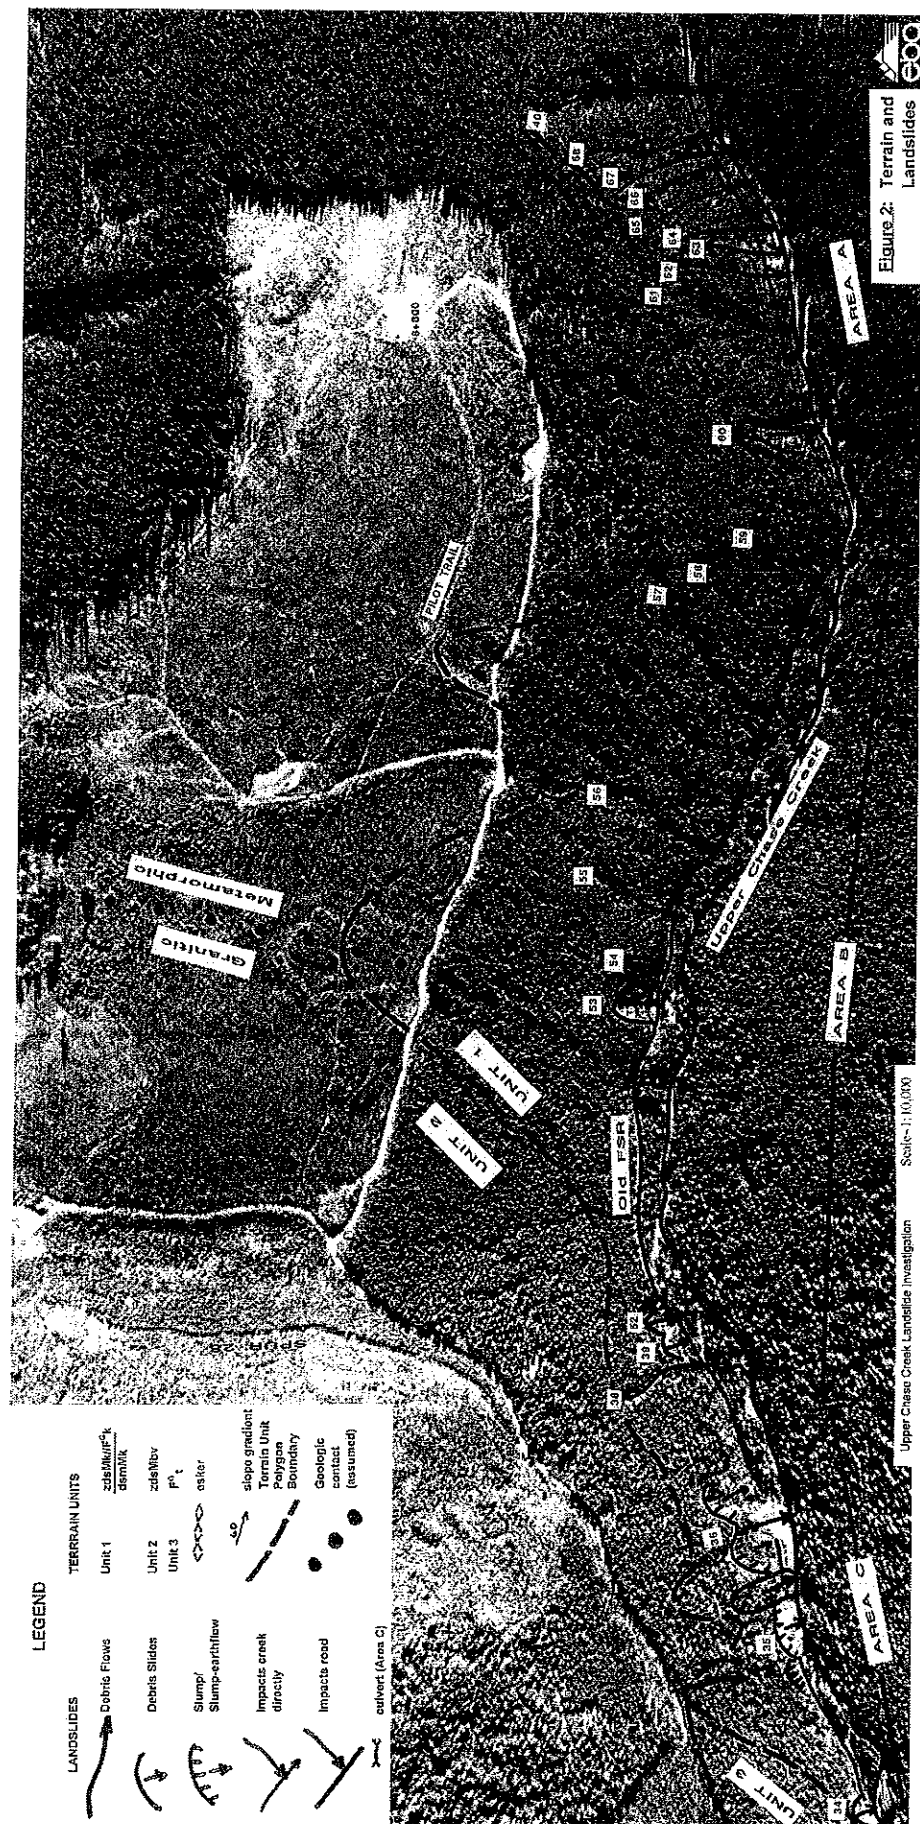
Fig. 2. Terrain and landslides in the Upper Chase Creek study area, 1996.

Detailed observations of the ditch-line, culverts and cross-ditches were made along 500 m of road above one of the most active slope failure areas (Area C, Figure 2). Water was being

directed down the road surface for distances of up to 200 metres. This redirected flow was observed to exit the road at several locations, including one about 100 m directly above a recently active, large slump failure, which was the largest single sediment source to Upper Chase Creek in the study area.

The 15 debris flows were primarily located towards the eastern end of the study area (Figure 2). They were from 150 to 250 metres long and were moderately to highly channelized. Through this region, Upper Chase Creek flowed against or close to the north valley wall, with little or no floodplain, and 7 debris flows deposited debris and sediment directly into Upper Chase Creek. The remaining 8 debris flows located to the west ran out on the Old FSR, which was further back from the creek in those locations.

The largest debris flow (Slide 40, Fig. 2) had occurred along the lower sidewalls and channel of a larger relic debris flow gully. It had recently failed, probably during the 1997 freshet. A slug of sediment and organic debris was observed in the channel and was being eroded by the creek, visibly increasing turbidity. This deposit was the second largest point source of sediment observed in the study area.

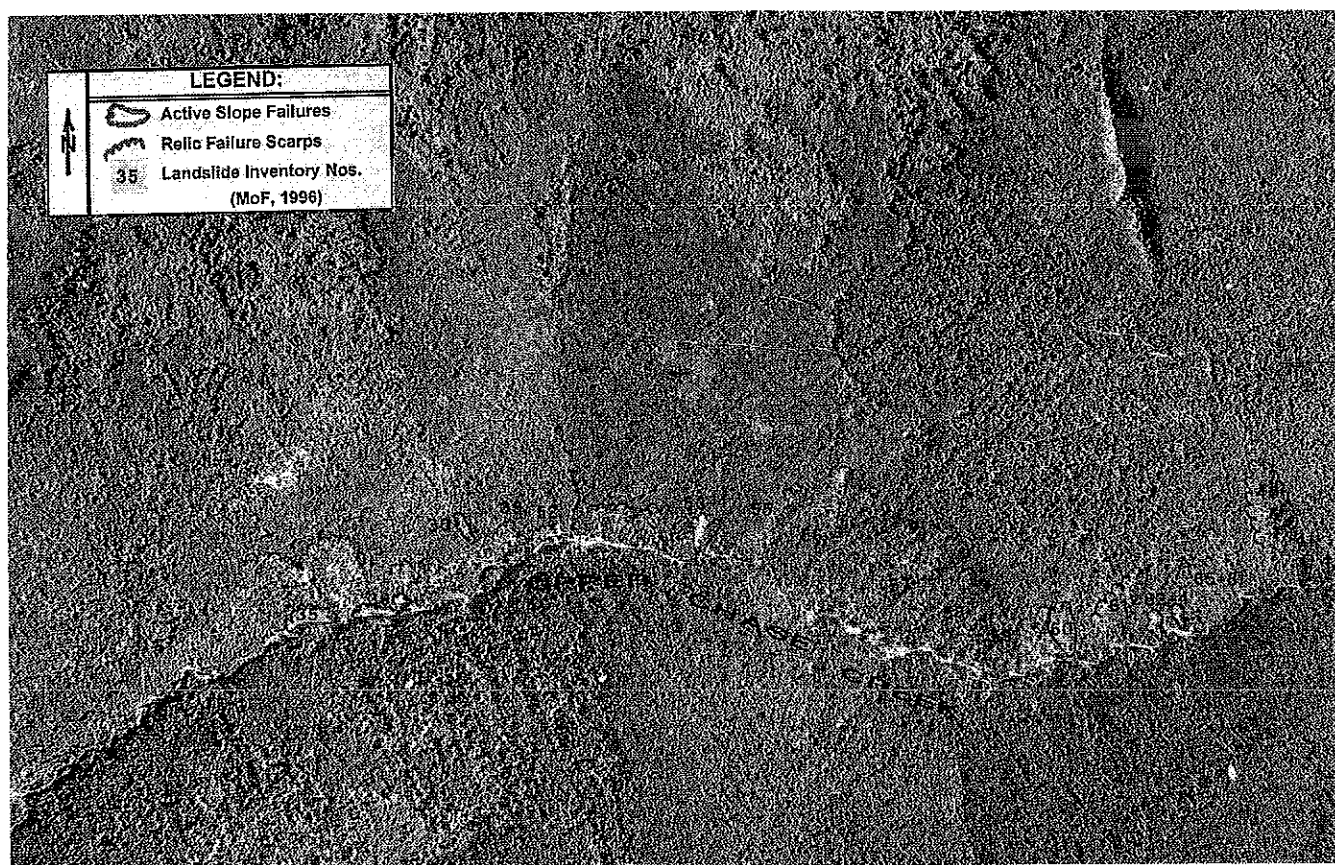
Fig. 3. Landslides in Upper Chase Creek study area, 1961.

This slide was very visible on the 1961 air photos (Fig. 3), as were relic lateral and backscarps delineating large areas upslope of the active area. On the ground it was observed that drainage from harvested upslope area had been intercepted and redirected down the Upper FSR, and onto slopes directly above the active area.

As discussed above, almost all landslides identified in the landslide inventory (MoF 1996) were clearly identifiable on 1961 air photos, taken prior to forestry development in the

watershed (Figure 3). The earlier photos show exposed soil and/or inactive, vegetated headscarps and slide paths, for all the currently active landslides in the study area.

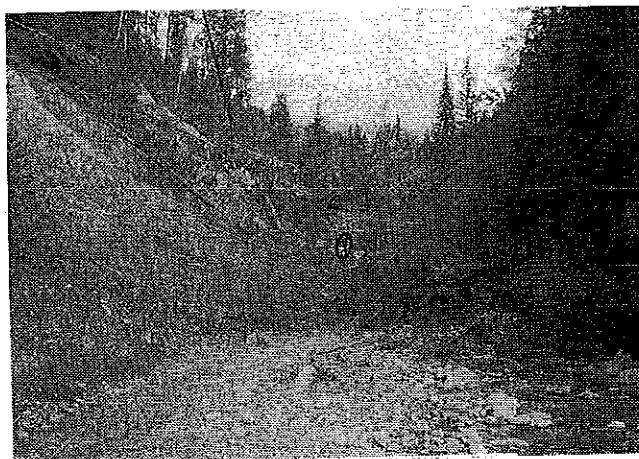
One portion of Slide 35/6 had failed into Upper Chase Creek in 1997, with the toe of the active slide having entered the wetted perimeter of Upper Chase Creek, redirecting streamflow from the north to the south side of the channel (Fig. 4). Freshly downed timber and slumping indicated that there was a high likelihood adjacent area would soon do the same.

- It was estimated that about 500 m³ of sediment was resting within the wetted perimeter of the channel, and this would likely be removed during the subsequent freshet.

Fig. 4. Toe of active portion of Slide 35/6 resting in Upper Chase Creek and redirecting creek to south side of wetted perimeter. Note circled person on slide surface for scale.

- About 2500 m³ of saturated sediment was perched directly behind this mass, with a surface slope gradient of 70 percent. This material had a high likelihood of entering Upper Chase Creek fairly rapidly (in a few weeks to months), if and when the sediment sitting in the creek was removed during the subsequent freshet.
- Renewed activity below the most active backscarp areas would be expected given continuing high groundwater levels. It was estimated that about 18,000 m³ of sediment would be mobilized in an area designated to be an immediate very high risk.
- It was estimated that about 90,000 m³ of sediment had been moving within the last 1 to 7 years, below the 280 m of continuous backscarp.

Finally, whatever their causes, suspended sediment loading and downstream drinking water quality were being detrimentally affected by the increases in landslide activity in the study area. A detailed geotechnical investigation was carried out on the large earth slump. Extensive mitigation measures were carried out in 1998 by Riverside Forest Products and Forest Renewal B.C. These included installation of horizontal drains to stabilize the deep-seated failure plane, and relocation of a short section of the Upper Chase Creek channel to prevent toe erosion and further destabilization along the shallow slide plane.

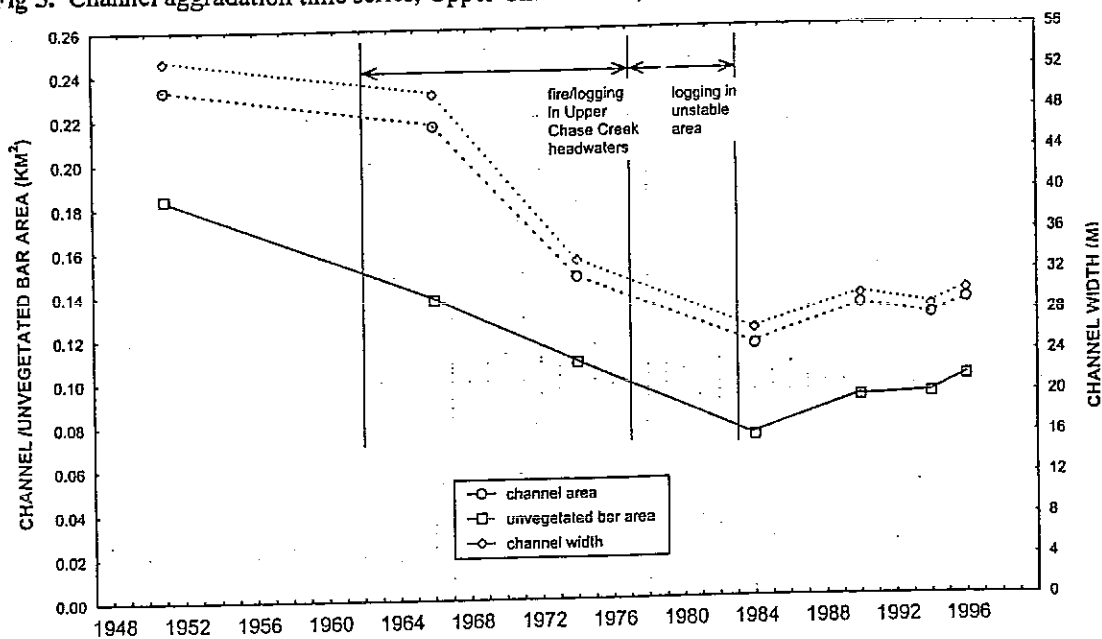
Fig 5. Channel aggradation time series, Upper Chase Creek, 1948 to 1996.

NHC had concluded that, "At some time between 1930 and 1951, Upper Chase Creek became very unstable and it delivered large volumes of sediment to its fan . . ." Figure 5 shows a decrease in sediment load from Upper Chase Creek for the period from 1951 to 1984. From 1984 to the present there was a less steep, but clearly definable increase in sediment delivery from Upper Chase Creek to Chase Creek. Land use changes in the upper watershed (SRK 1997) are also shown on Fig. 5.

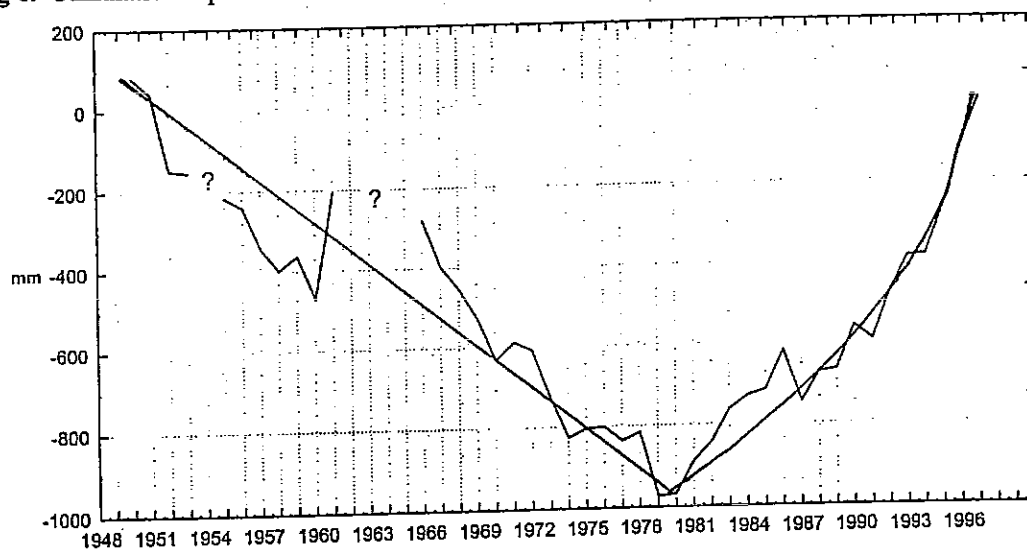
Fig 6. Cumulative departure from the mean for total annual precipitation, Westwold, B.C., 1948 to 1996.

There was a trend of greater than average precipitation from the start of the record in 1922 to about 1940 (not shown), a clear trend of lower than average precipitation from 1940 to 1980, and a clear trend of higher than average precipitation from 1980 to 1997.

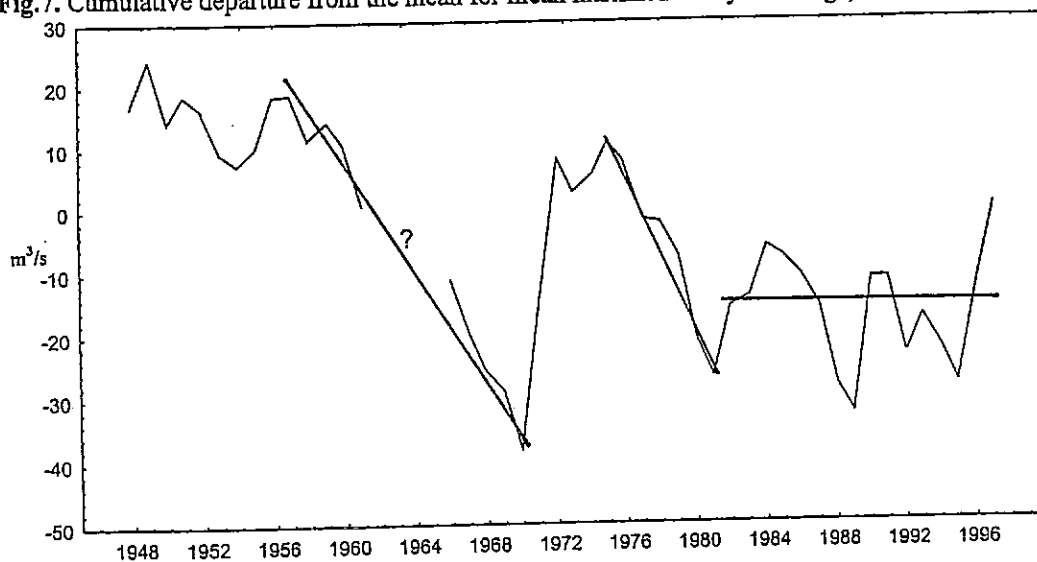
Fig.7. Cumulative departure from the mean for mean maximum daily discharge, Salmon River at Falkland, 1948 to 1996.

The cumulative departure from the mean analysis shows a negative trend - consistently less than normal peak flows - from about 1956 to 1970 and from 1975 to 1981, interrupted by a small cluster of extreme events in 1971 and 1972. From 1981 on, no clear trend was detected.
