REPORT OF MARINE SURVEY

CONDITION & VALUATION

1989 CARVER 3467 SANTEGO

M/V “ [REDACTED] ”

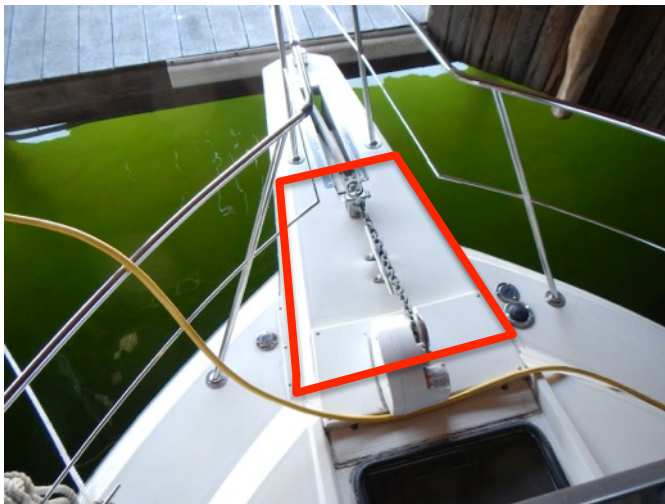
- The vessel's bow pulpit structure was identified as soft / delaminated when inspected at time of survey inspection. Percussion hammer soundings were dull, moisture meter readings were elevated, there is visual indentation where the deck cleat is fastened to the pulpit structure, and the structure is physically soft when pressure is applied with a foot or hand. Vessel's foredeck structure appears in structurally sound condition. Pulpit structure is separate from foredeck structure. Recommend monitor condition of pulpit structure, and service / repair or renew as required.

Pulpit structure is soft

1. The vessel's bow pulpit structure was identified as soft / delaminated when inspected at time of survey inspection. Percussion hammer soundings were dull, moisture meter readings were elevated, there is visual indentation where the deck cleat is fastened to the pulpit structure, and the structure is physically soft when pressure is applied with a foot or hand. Vessel's foredeck structure appears in structurally sound condition. Pulpit structure is separate from foredeck structure. Recommend monitor condition of pulpit structure, and service / repair or renew as required.
2. There were several deck cleats that were slightly loose when tapped with percussion hammer at time of survey inspection. Recommend service / tighten all vessel's deck cleats as required.

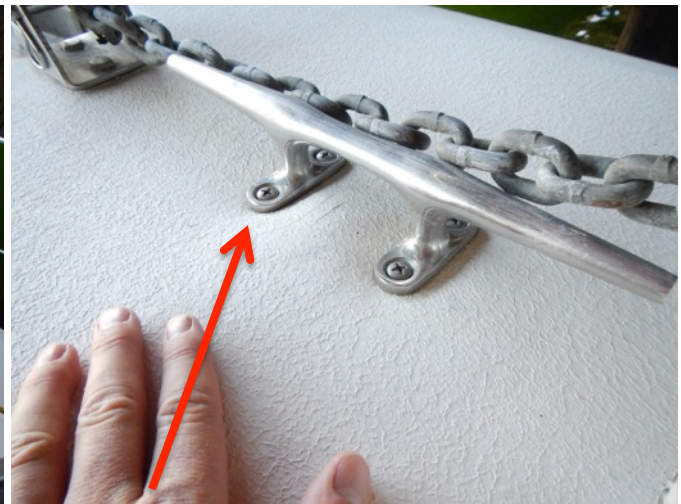
Indentation at pulpit cleat

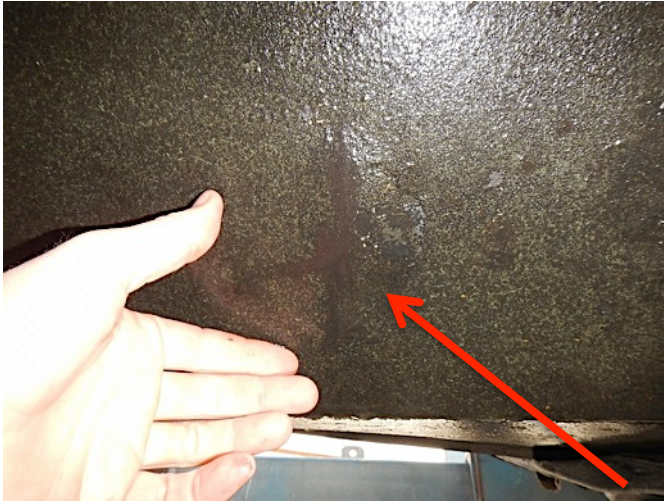
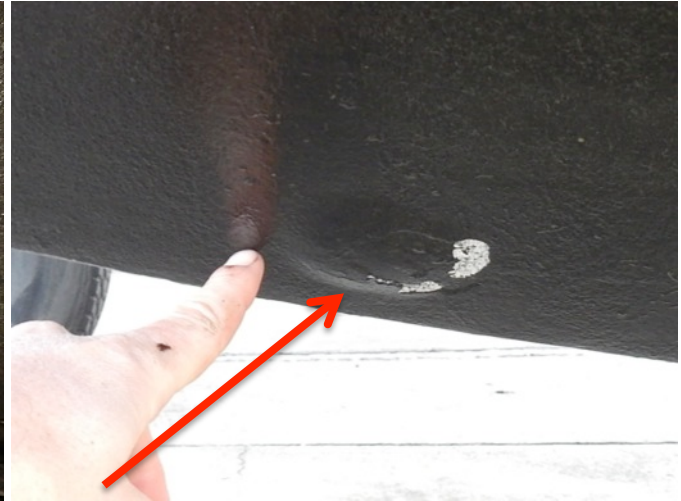
- There were approximately 10 to 20 blisters sighted at the vessel's wetted surface area at time of haul-out inspection. Blisters sighted ranged in size from 1" diameter to 8" in diameter. Blisters were not lanced at time of inspection. Severity of blister penetration is undetermined. Recommend monitor quantity, size, location, and condition of blisters each time vessel is hauled out of the water, and service / repair blisters as required.

Blisters at wetted surface area

4. There were approximately 10 to 20 blisters sighted at the vessel's wetted surface area at time of haul-out inspection. Blisters sighted ranged in size from 1" diameter to 8" in diameter. Blisters were not lanced at time of inspection. Severity of blister penetration is undetermined. Recommend monitor quantity, size, location, and condition of blisters each time vessel is hauled out of the water, and service / repair blisters as required.

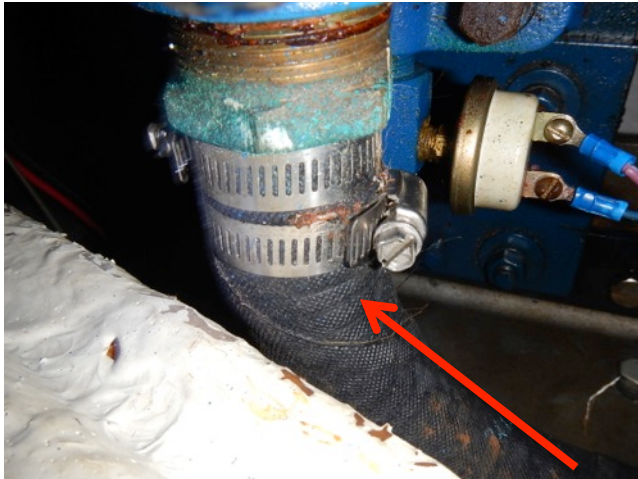
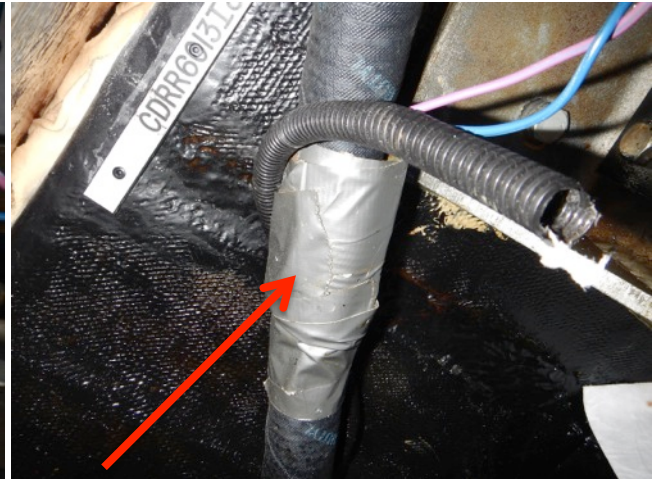
Main engine raw water intake hoses appear in questionable condition

5. The raw water intake hoses to the main engines appear old and in questionable condition. There is duct tape wrapped around one raw water intake hose. The wire reinforcement is poking through on a second raw water intake hose. Recommend monitor condition of vessel's main engine raw water intake hoses, and renew hoses as required.

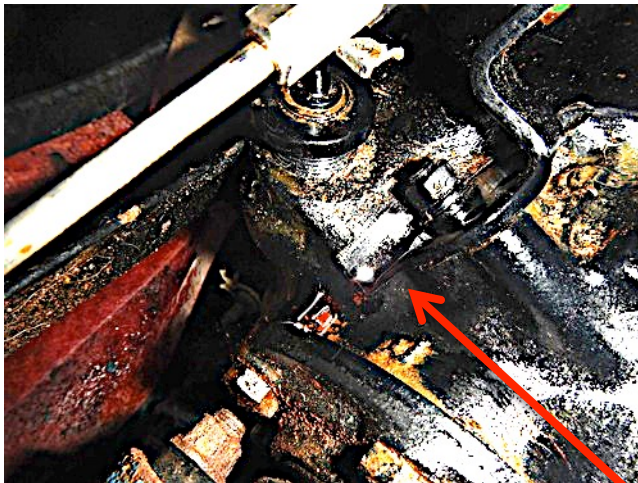
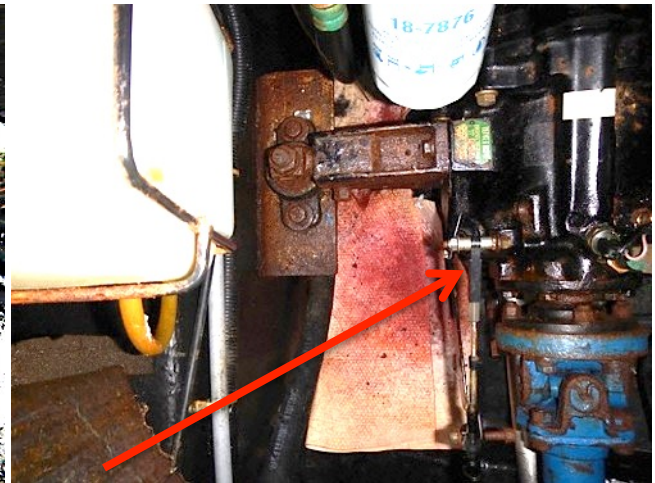
ATF leak at port engine Velvet Drive gear

1. There is evidence of an ATF gear fluid sighted at an absorbent pad below the port side engine Velvet Drive / Borg Warner gear. There was a visible gear fluid leak sighted at the Velvet Drive gear select lever of the port engine gear. Recommend service / repair port engine Velvet Drive gear as required.

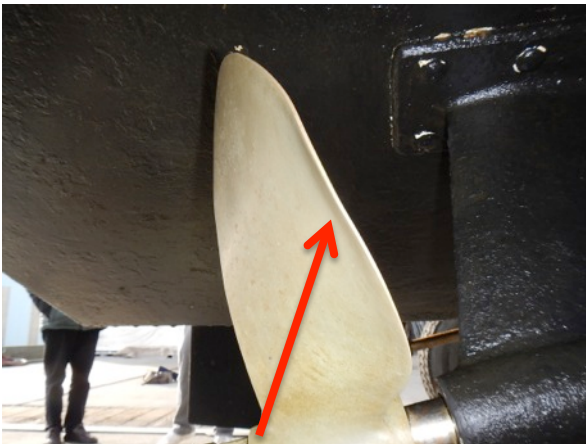
Prop blade is bent

2. One prop blade at both port & starboard props is slightly bent / out of alignment. Damage described appears minor & serviceable. Recommend service / tune & balance vessel's props at time of vessel's next scheduled haul-out.

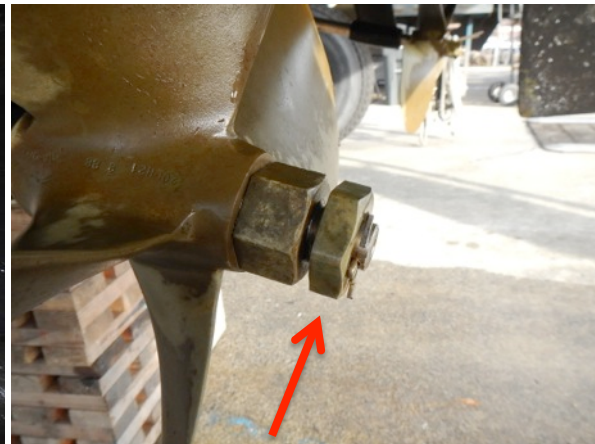
Prop nut is loose

3. The aft most prop nut at the port side prop shaft is loose. The port side prop nut that secures the prop is tight at the prop hub. Recommend service / adjust / tighten loose prop nut described at time of vessel's next scheduled haul-out.

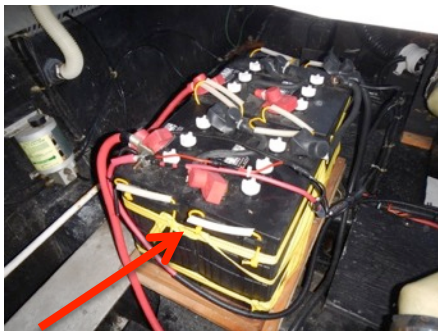
ABYC Standards recommends: *Each installed battery shall not move more than one inch in any direction when a pulling force of 90 pounds or twice the battery weight, whichever is less, is applied through the center of gravity of the battery (ABYC E-10.7.4).*

Battery mounting materials and surfaces shall withstand electrolyte attack (ABYC E-10.7.1). Provision shall be made to contain incidental leakage and spillage of electrolyte (ABYC E-10.7.2).

House Bank not secured on plywood sole

Recommend install battery boxes or battery tray, and secure batteries at their mounted location in accordance with ABYC standards stated above.

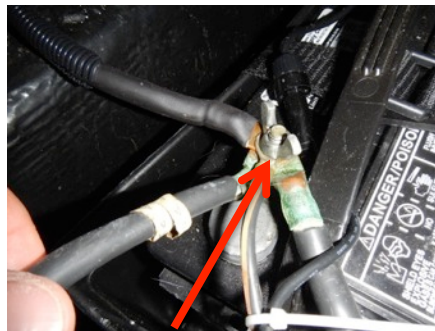
- The 12V Dyno Start Bank batteries use wing nut fasteners to secure conductors to battery terminals.
ABYC Standards recommends: *Battery cables and other conductors size 6 AWG and larger shall not be connected to the battery with wing nuts (ABYC E-10.8.3).*
Recommend renew wing nut fasteners described with marine grades stainless steel hex nut style fasteners at battery terminals.

Wing nut fasteners

ABYC Standards recommends: *Battery cables and other conductors size 6 AWG and larger shall not be connected to the battery with wing nuts (ABYC E-10.8.3).*

Recommend renew wing nut fasteners described with marine grades stainless steel hex nut style fasteners at battery terminals.

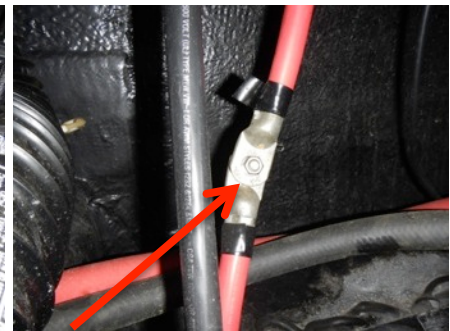
- There are two locations in the engine compartment where the ungrounded (positive) conductor to the inverter system is not protected / shielded form accidental termination.
ABYC Standards recommends: *Continuously energized parts, such as positive battery terminals and both ends of all wire connected thereto, shall be physically protected with boots, or other form of protection, that cover all energized surfaces to prevent accidental short circuits (ABYC E-11.5.4.7.5).*
Recommend install protection at all positive conductor ends in accordance with ABYC standards stated above.

Unprotected positive DC conductors

ABYC Standards recommends: *Continuously energized parts, such as positive battery terminals and both ends of all wire connected thereto, shall be physically protected with boots, or other form of protection, that cover all energized surfaces to prevent accidental short circuits (ABYC E-11.5.4.7.5).*

Recommend install protection at all positive conductor ends in accordance with ABYC standards stated above.

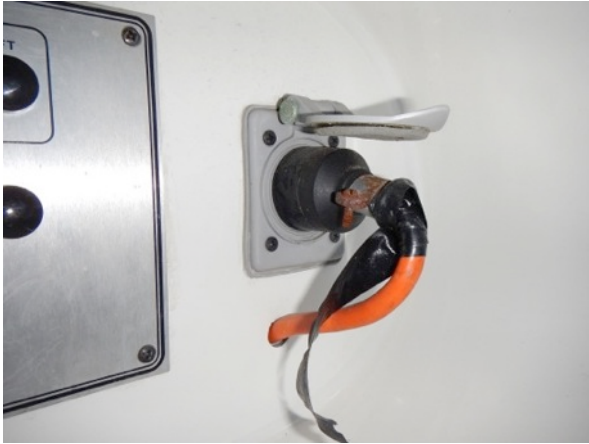
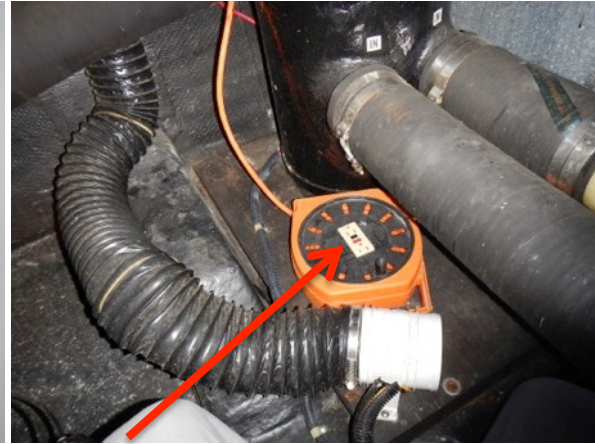
- A 120V AC power outlet receptacle / extension cord has been installed in the vessel's gasoline engine compartment. AC power outlet receptacles are not ignition protected.
ABYC Standards recommends: *Potential electrical sources of ignition located in spaces containing gasoline powered machinery, or gasoline fuel tank(s), or joint fitting(s), or other connection(s) between components of a gasoline system, shall be ignition protected (ABYC E-11.5.3.1).*
Recommend removal of AC power system outlet receptacle described in accordance with ABYC standard stated above.
- There are two systems on the 120V AC power distribution panel that are labeled incorrectly. The breakers labeled "Range" & "Ice Maker" power on two separate electric heaters. The "Range" has been changed to a propane stove, and the "Ice Maker" was not sighted onboard the vessel at time of survey inspection.

120V AC power outlet is not ignition protected

4. A 120V AC power outlet receptacle / extension cord has been installed in the vessel's gasoline engine compartment. AC power outlet receptacles are not ignition protected.
ABYC Standards recommends: Potential electrical sources of ignition located in spaces containing gasoline powered machinery, or gasoline fuel tank(s), or joint fitting(s), or other connection(s) between components of a gasoline system, shall be ignition protected (ABYC E-11.5.3.1).
Recommend removal of AC power system outlet receptacle described in accordance with ABYC standard stated above.

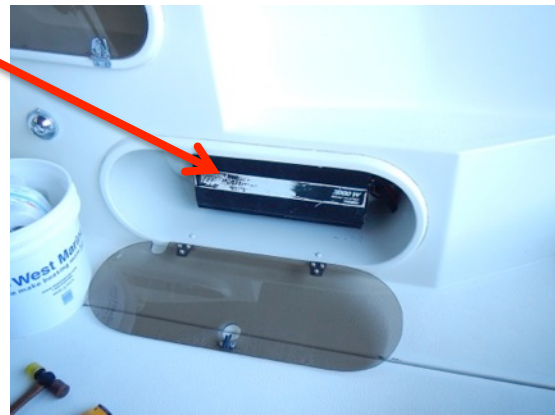
ABYC Standards recommends: *Battery chargers, inverters, and inverter/chargers shall be installed in a ventilated, dry, accessible location (ABYC A-31.5.5.2.1).*

Potential electrical sources of ignition located in spaces containing gasoline powered machinery, or gasoline fuel tank(s), or joint fitting(s), or other connection(s) between components of a gasoline system, shall be ignition protected (ABYC E-11.5.3.1).

5. The power inverter is currently installed at a weather deck location which is susceptible to water exposure. The power inverter is not marked as marine grade or ignition protected.
ABYC Standards recommends: Battery chargers, inverters, and inverter/chargers shall be installed in a ventilated, dry, accessible location (ABYC A-31.5.5.2.1).
Potential electrical sources of ignition located in spaces containing gasoline powered machinery, or gasoline fuel tank(s), or joint fitting(s), or other connection(s) between components of a gasoline system, shall be ignition protected (ABYC E-11.5.3.1).
Recommend reconfigure power inverter in accordance with ABYC standards stated above.

Recommend reconfigure power inverter in accordance with ABYC standards stated above.

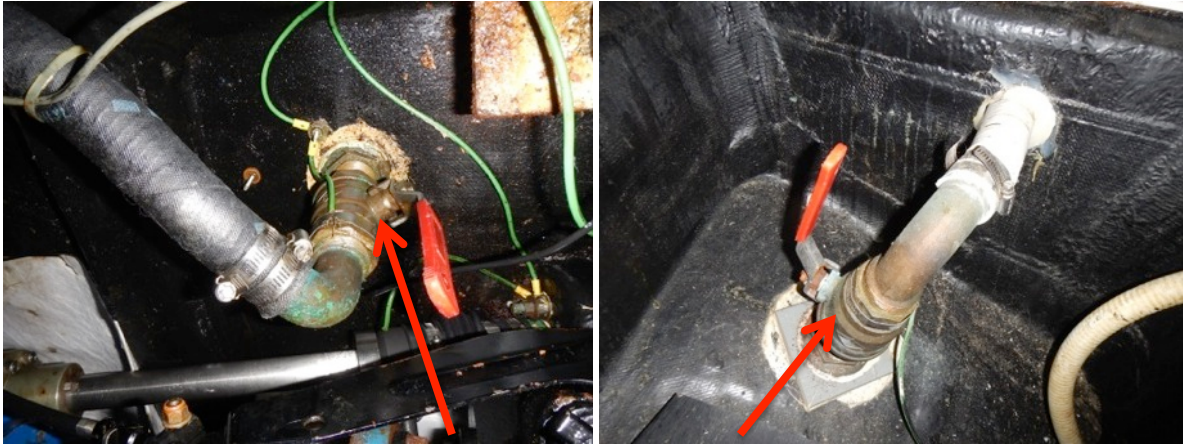
- The starboard side main engine & waste tank discharge seacocks were not functional by hand when tested at time of survey inspection. Recommend service & exercise all vessel's ball valve seacocks so that all seacocks are operable by hand incase of emergency.
- The handle of the ball valve seacock for the toilet raw water intake system was loose when tested at time of survey inspection. Recommend service / tighten handle at toilet intake seacock as required.

Starboard engine & waste tank discharge seacocks are not functional

4. The starboard side main engine & waste tank discharge seacocks were not functional by hand when tested at time of survey inspection. Recommend service & exercise all vessel's ball valve seacocks so that all seacocks are operable by hand in case of emergency.

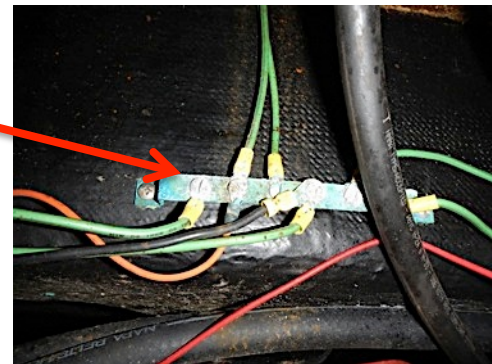
- Some of the vessel's bonding system terminals appear in corroded condition. Corrosion creates resistance at the conductor, and limits the effectiveness of the bonding conductor & overall bonding system. Recommend service / clean corrosion from bonding terminals & conductor ends as required.

6. Some of the vessel's bonding system terminals appear in corroded condition. Corrosion creates resistance at the conductor, and limits the effectiveness of the bonding conductor & overall bonding system. Recommend service / clean corrosion from bonding terminals & conductor ends as required.

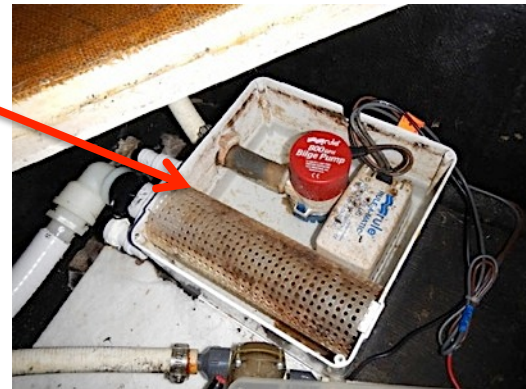
- The cover of the shower sump pump was not secured when sighted at time of survey inspection. Recommend secure shower sump pump cover as required.

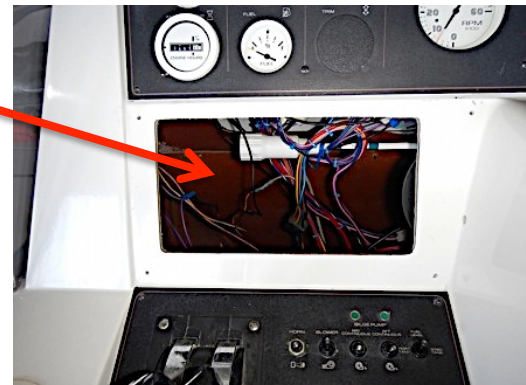
- There was a hole in the flybridge dash at time of survey inspection that appears to formerly contain a piece of navigation equipment. Recommend cover hole in dash as required.

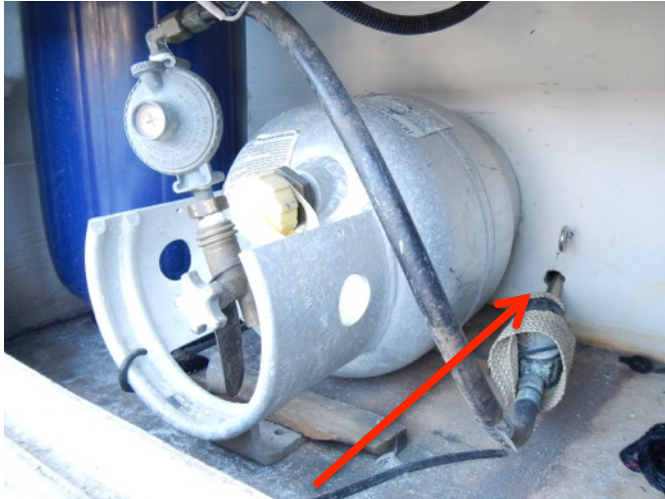
ABYC Standards recommends: *Lockers used to contain LPG cylinders, cylinder valves, regulating equipment and safety devices shall be designed to minimize the likelihood of use as a gear storage locker (ABYC A-1.8.1) and shall be, vapor tight to the hull interior (A-1.8.1.1), and located above the waterline (A-1.8.1.2), and constructed of, or lined with, corrosion resistant materials (A-1.8.1.3), and shall open only from the top (A-1.8.1.4) with a gasketed cover that shall latch tightly (A-1.8.1.5), and shall be capable of being quickly and conveniently opened without tools (A-1.8.1.6).*

LPG locker not vapor tight to hull interior

6. The vessel's propane tank is mounted in a locker that opens from the side at the transom location. The locker is not vapor tight to the hull / engine compartment interior. The system is not equipped with a pressure gauge, and there is a kink in the gas supply line near the regulator fitting.
ABYC Standards recommends: Lockers used to contain LPG cylinders, cylinder valves, regulating equipment and safety devices shall be designed to minimize the likelihood of use as a gear storage locker (ABYC A-1.8.1) and shall be, vapor tight to the hull interior (A-1.8.1.1), and located above the waterline (A-1.8.1.2), and constructed of, or lined with, corrosion resistant materials (A-1.8.1.3), and shall open only from the top (A-1.8.1.4) with a gasketed cover that shall latch tightly (A-1.8.1.5), and shall be capable of being quickly and conveniently opened without tools (A-1.8.1.6).
Each system shall be fitted with a pressure gauge. The gauge shall read the cylinder pressure side of the pressure regulator (ABYC A-1.5.2).

Recommend reconfigure vessel's LPG / Propane system in accordance with ABYC standards stated above.

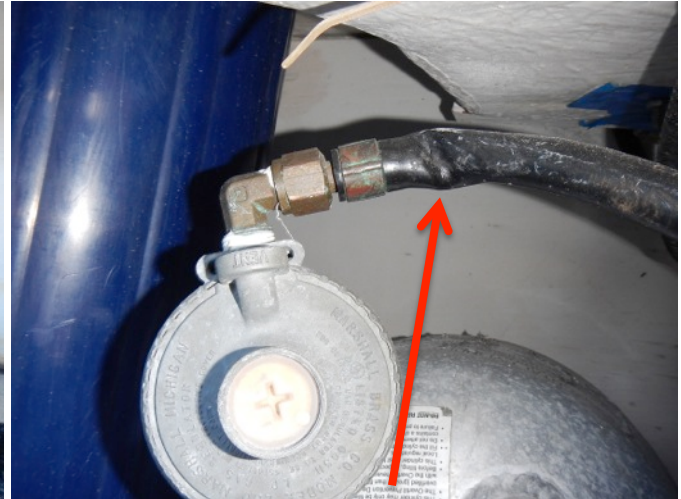
As installed, the fuel supply line system and its components shall be compatible with LPG, and shall withstand the stresses and exposure of the marine environment (ABYC A-1.9.1). LPG fuel supply line shall comply with the construction, performance, manufacturing and test, and marking requirements of UL 21, LP Gas Hose (A-1.9.2).

Kink in LPG supply line

As installed, the fuel supply line system and its components shall be compatible with LPG, and shall withstand the stresses and exposure of the marine environment (ABYC A-1.9.1). LPG fuel supply line shall comply with the construction, performance, manufacturing and test, and marking requirements of UL 21, LP Gas Hose (A-1.9.2).
Recommend reconfigure vessel's LPG / Propane system in accordance with ABYC standards stated above.

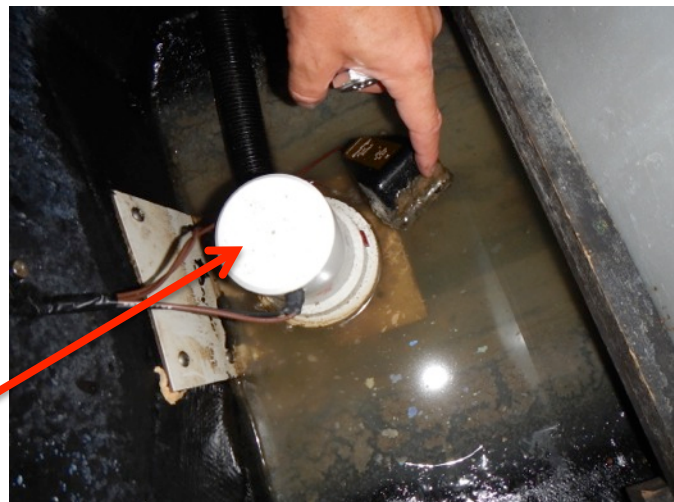
- All distress signal flares sighted onboard the vessel at time of survey inspection were EXPIRED
USCG 46 CFR regulations state: *All vessels 16ft. and larger are required to carry 3 distress signal flares suitable for day & night use (3 day & 3 night, or 3 rated for day or night use). (46 CFR 175.110). No person may use a boat unless each signal required by sec. 175.110 is in serviceable condition and the service life of the signal, if indicated by a date marked on the signal, has not expired. (46 CFR 175.125).*
Equip vessel in accordance with USCG CFR regulations stated above.
- The aft bilge pump would not power on with the manual switch at the flybridge location, but did power on with automatic float switch at the pump location. Recommend service / repair or renewal of bilge pump components as required.

1. All distress signal flares sighted onboard the vessel at time of survey inspection were EXPIRED
USCG 46 CFR regulations state: *All vessels 16ft. and larger are required to carry 3 distress signal flares suitable for day & night use (3 day & 3 night, or 3 rated for day or night use). (46 CFR 175.110). No person may use a boat unless each signal required by sec. 175.110 is in serviceable condition and the service life of the signal, if indicated by a date marked on the signal, has not expired. (46 CFR 175.125).*
Equip vessel in accordance with USCG CFR regulations stated above.
