Case Study 3: Large Scale Mould Remediation

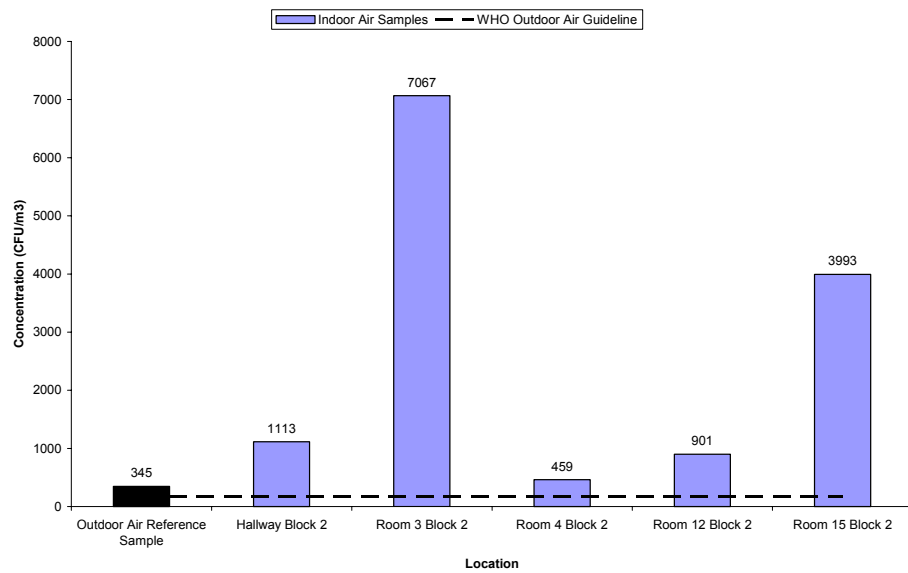
- Extremely high airborne fungal levels in block of rooms and in hall ways (indoor avg = 2170 CFU/m³, outdoor avg = 345 CFU/m³)
- Extremely high surface fungal levels on ceilings, wardrobes, walls.

Figure 1 Airborne Fungal Concentration: Pre-Remediation

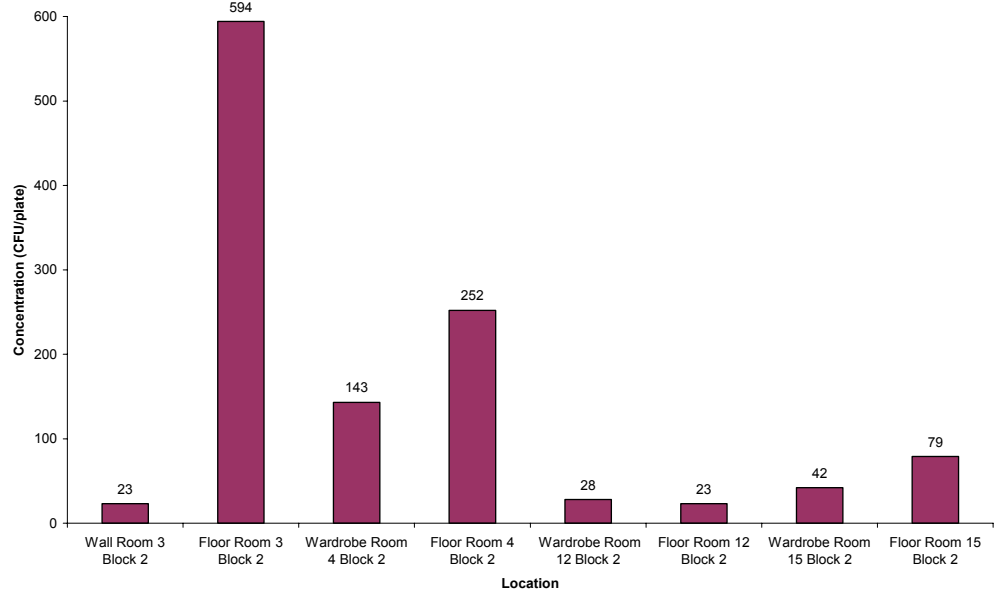
Figure 1 Surface Fungal Concentration: Pre-Remediation

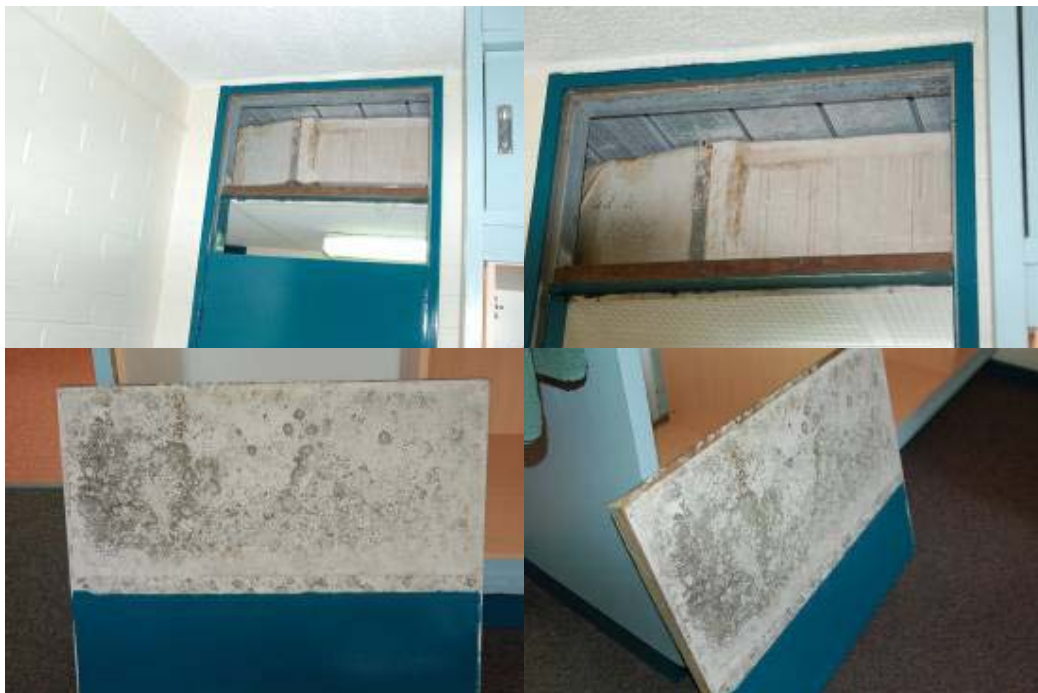
Figure 3 Heavy mould contamination of HVAC ducting and panels

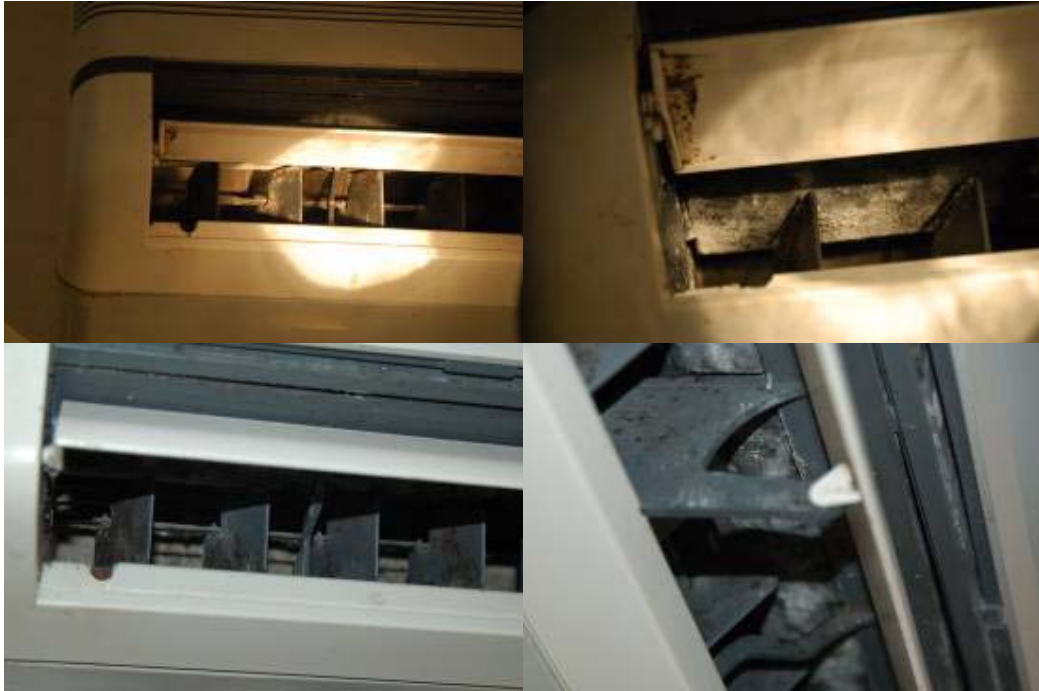
Figure 4 Mould contaminated split air conditioning systems

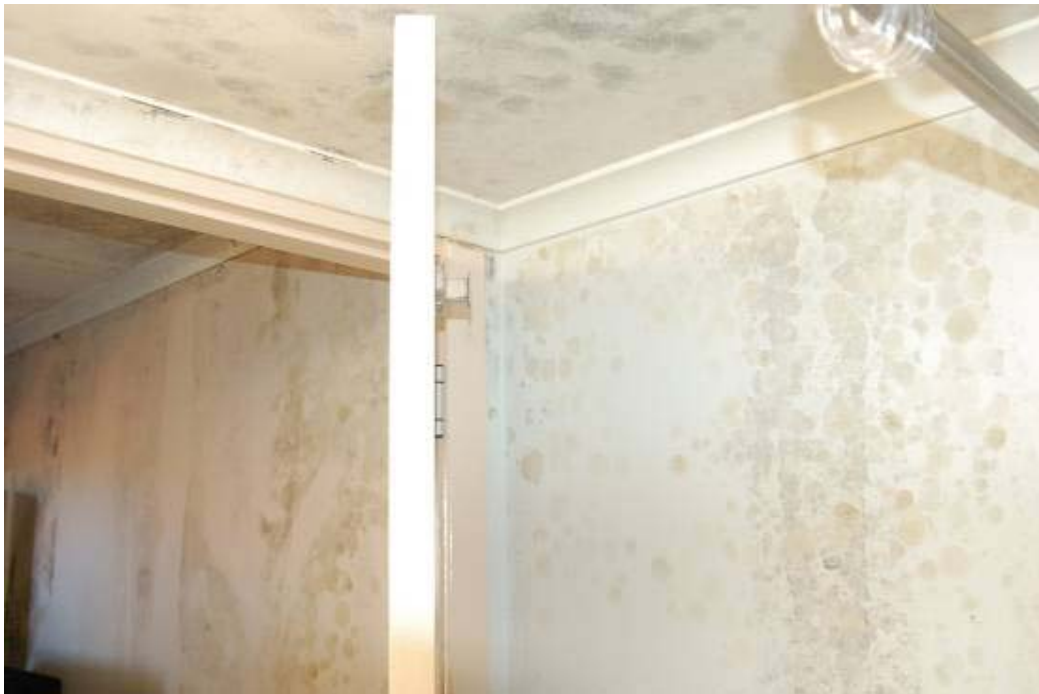
Figure 5 Heavy mould contamination on walls and ceilings

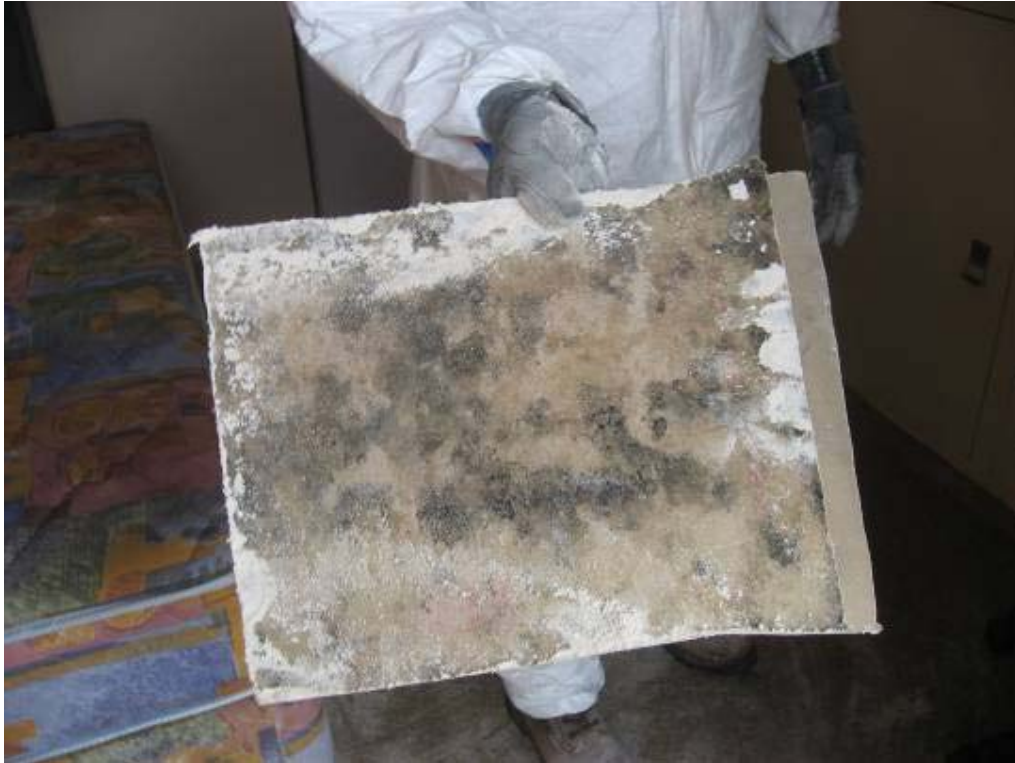
Figure 6 Underside of mould contaminated gyprock ceilings

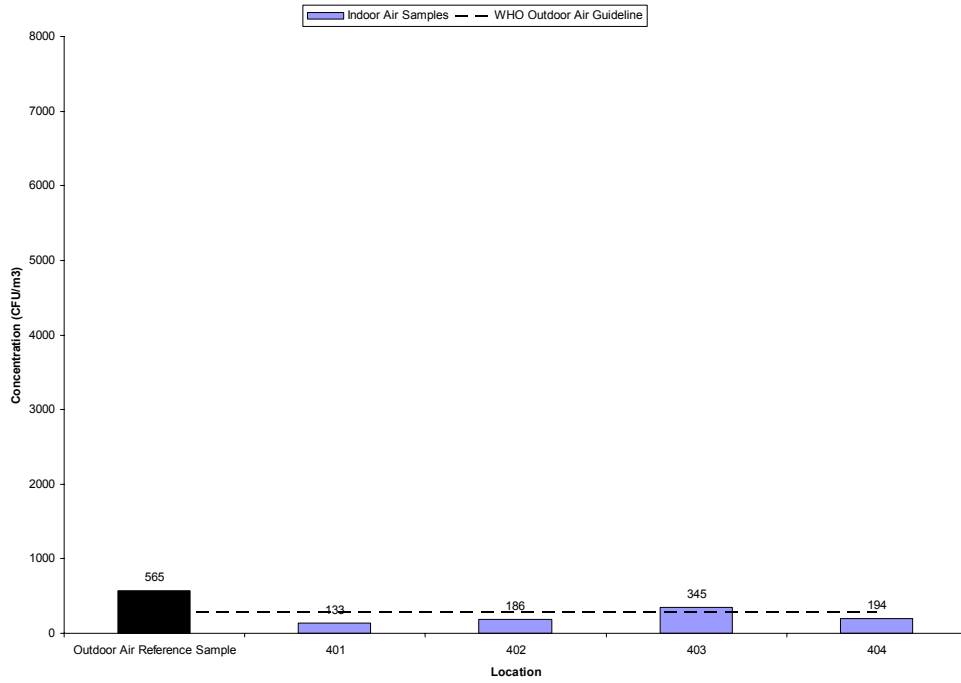
- Low airborne and surface fungal levels

Figure 14 Airborne Fungal Spore Concentration (spores/m³): Post – Remediation

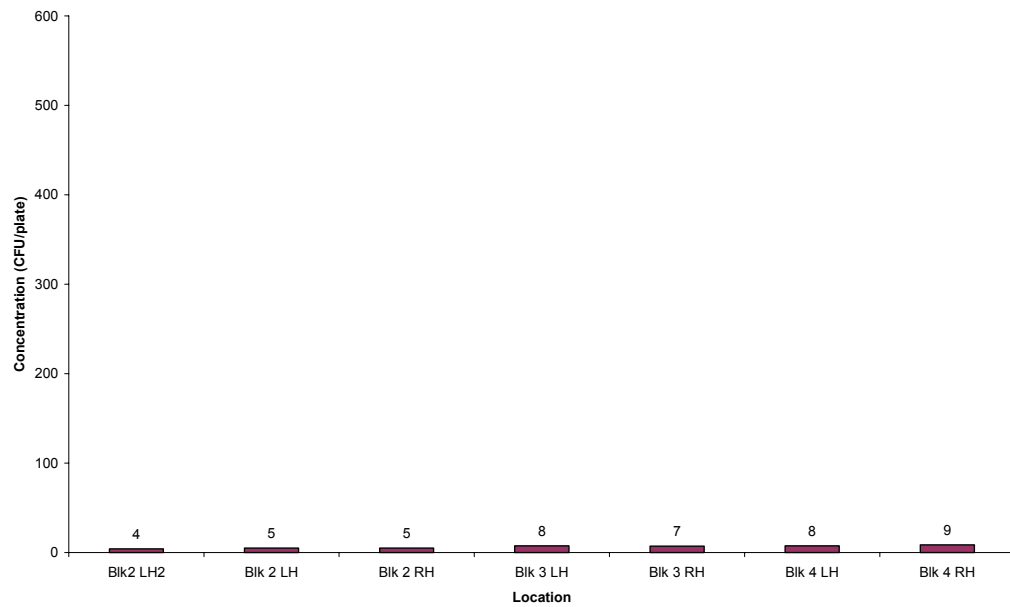
Figure 15 Surface Fungal Spores Concentration: Post – Remediation
