Case Study 2: Sub Floor Mould Remediation

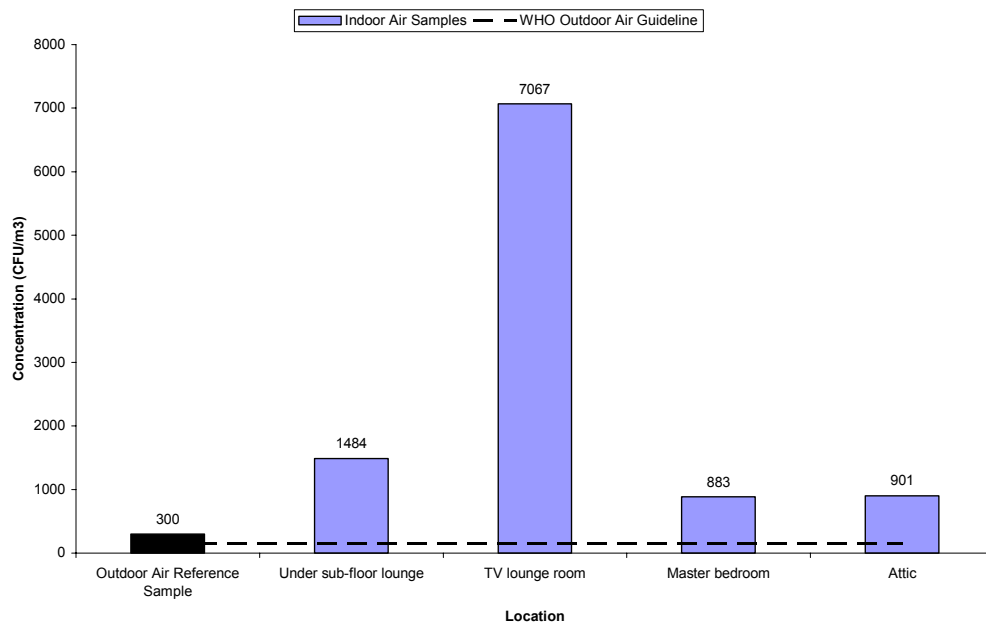
- Extremely high airborne fungal levels in sub floor (1484 CFU/m³) and room above (7067 CFU/m³)
- Extremely high surface fungal levels on subfloor beams, joists and floor boards

Figure 1 Airborne Fungal Concentration: Pre-Remediation

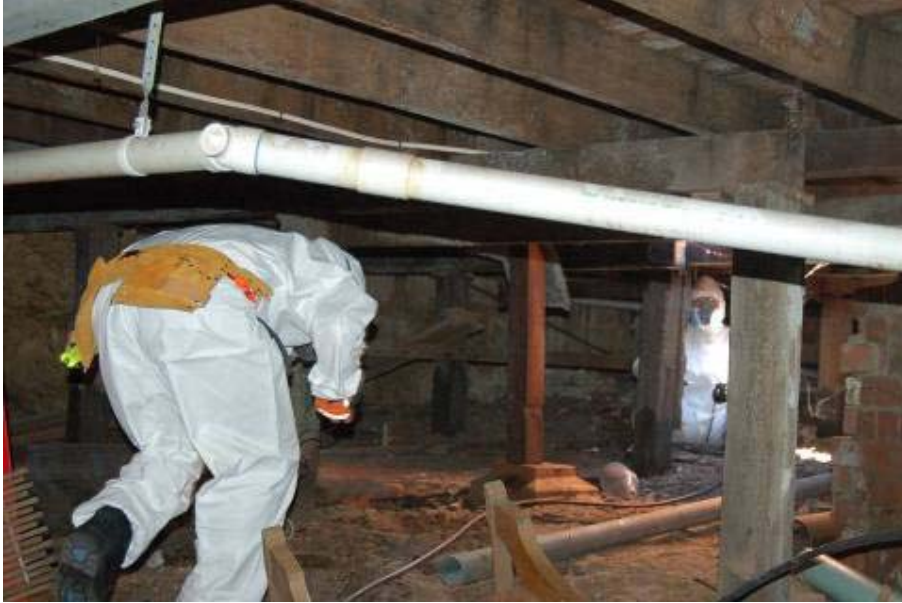
Figure 2 Sub-floor inspection

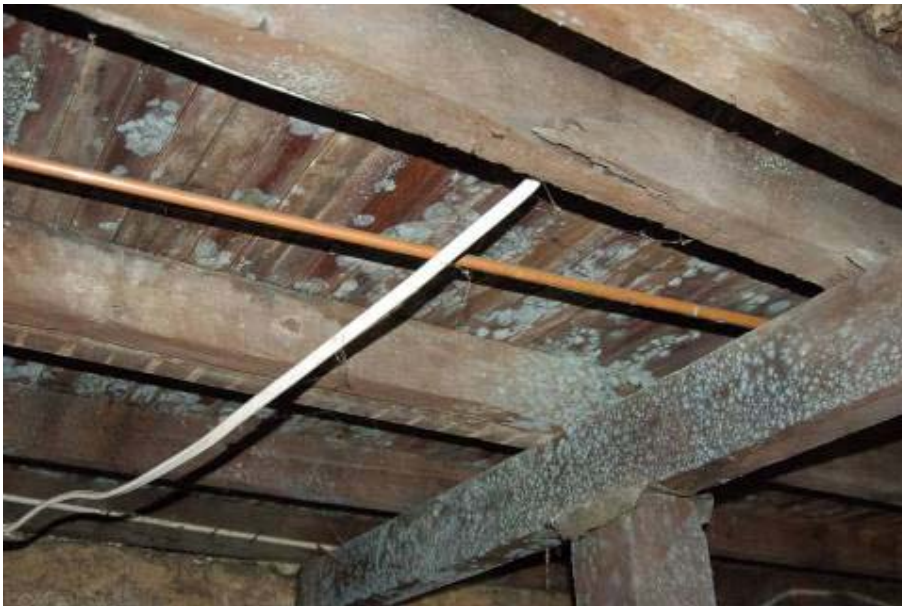
Figure 3 Heavy visible sub-floor mould contamination

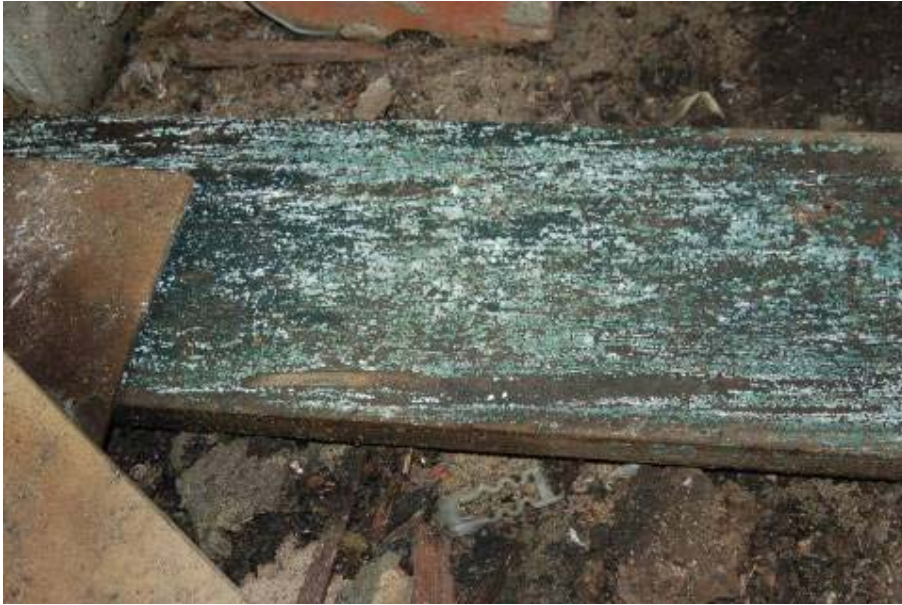
Figure 4 Mould contamination of underside of floor boards

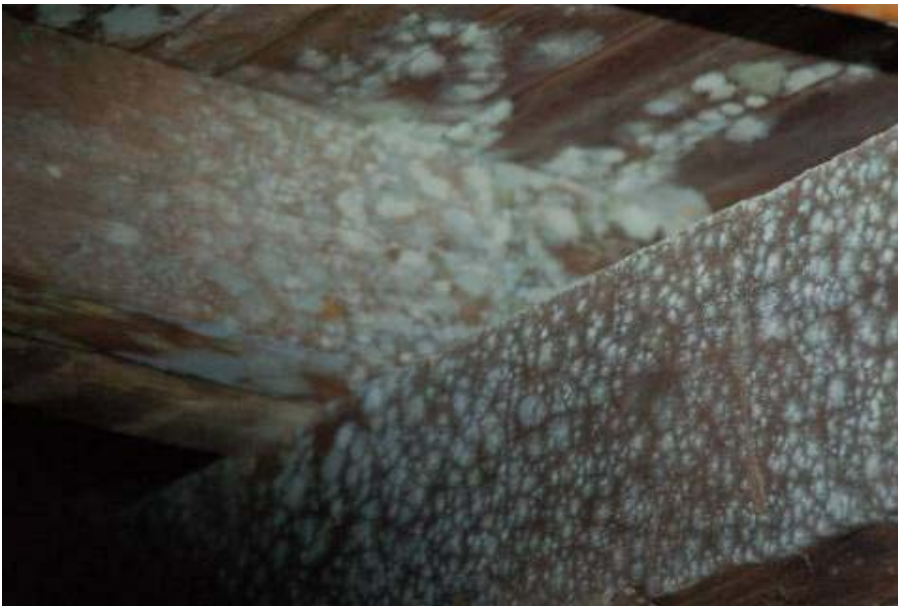
Figure 5 Close up of mould contamination on sub-floor timber

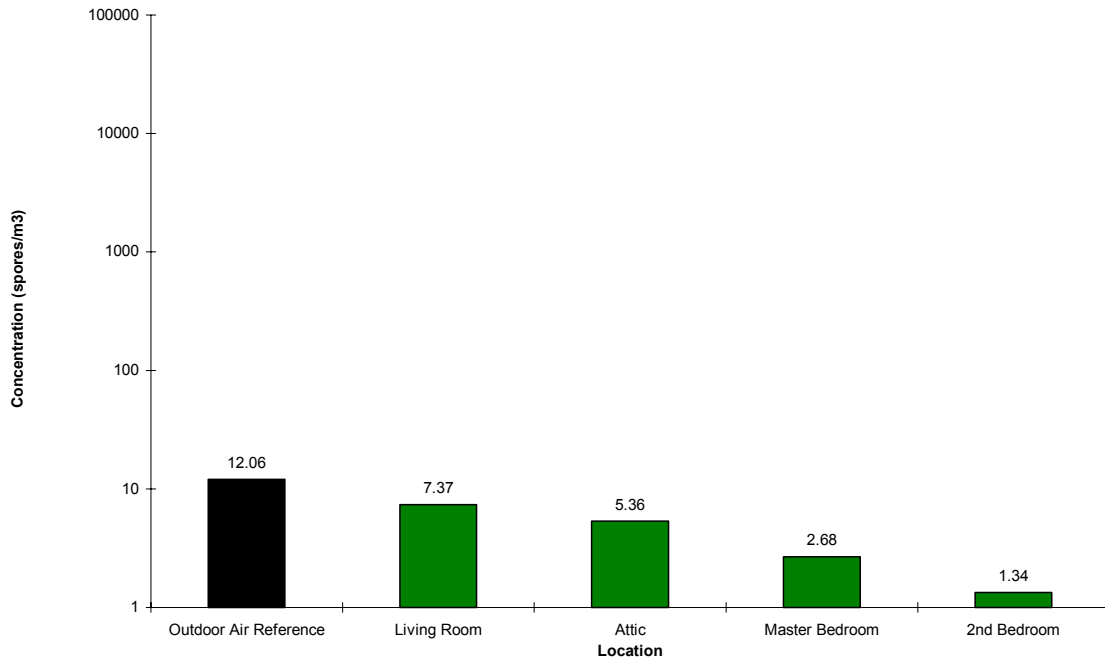
- Low airborne and surface fungal levels

Figure 11 Airborne Fungal Spore Concentration (spores/m³): Post – Remediation

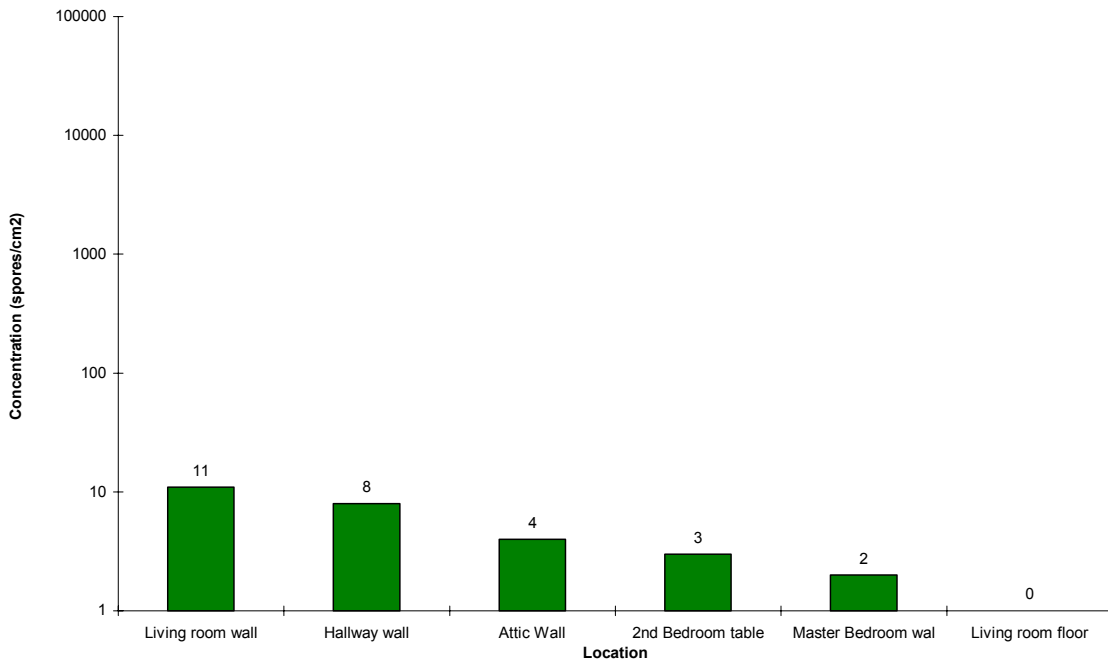
Figure 11 Surface Fungal Spores Concentration: Post – Remediation
