# THETA CHI Fraternity

## Feasibility Study & Conditions Analysis

**THETA CHI of Penn State  
Omega Chapter  
523 South Allen Street  
State College, PA 16801**

**April 11, 2011**

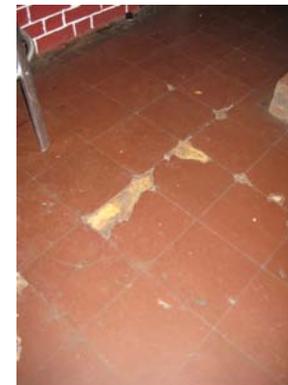
The bar area with the broken glass block and failing lintel above. This is most likely caused by water penetration at the decaying slab edge above.

Minimal water damage to the ceiling was noted above. Correct sealing and repair of the porch slab above should help resolve this.

No asbestos report was available however the flooring resembles a Vinyl Asbestos Flooring. Given the failing and possible friable nature, this product should be environmentally tested and replaced if necessary.

The terrazzo floor is in good condition. The stairs leading to the dining area are in disrepair. Treads should be replaced in their entirety as these are becoming a safety issue.

Windows in the areaways have been replaced.

French doors both to the bar and to the exterior should be replaced.

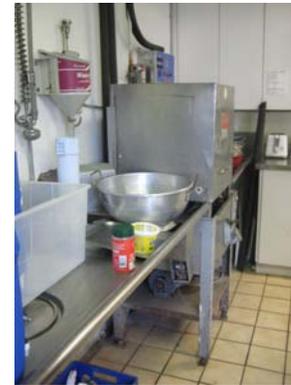
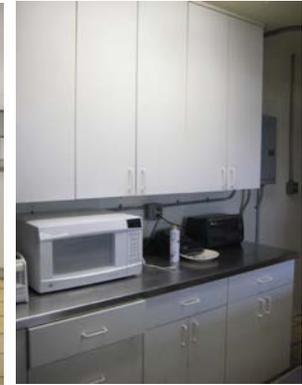
### Kitchen

Kitchen equipment is aged but appears to continue to function. The hood ansul system has been tested and functions.

Some of the quarry tile is cracked and in disrepair.

The floor has sunk in an area under the oven. It appears that the slab has sunk thus cracking the quarry tile.

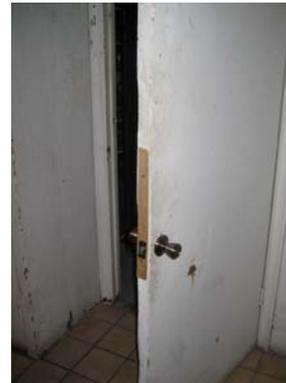
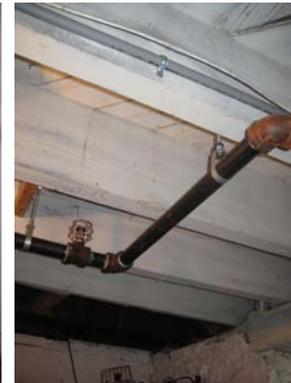
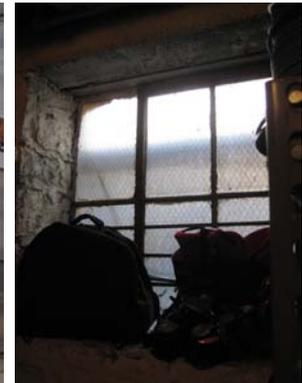
### Storage Room

The window in the storage room is original steel frame window. Replacement of this and other existing windows in the facility would improve energy efficiency.

A photograph showing the wood frame structure of the facility and the recently installed sprinkler system.

The door to the storage room is in need of replacement.

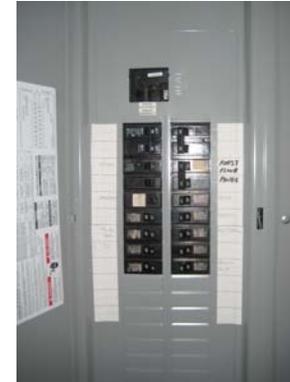
### Laundry Room

The laundry equipment is leased and is in good condition.

The flooring is VCT. This appears to be in reasonable condition.

Walls are painted paneling.

Pictured to the right is one of two 200 amp panels. This panel is reasonably new and appears to satisfy the current needs.

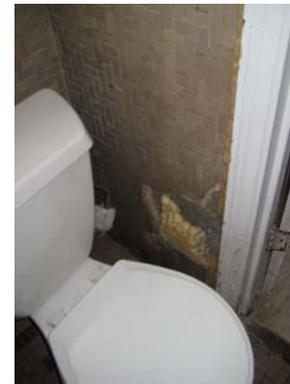
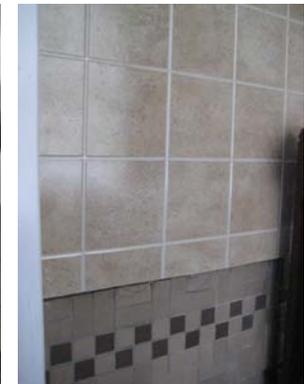
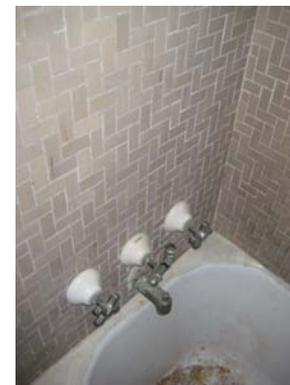
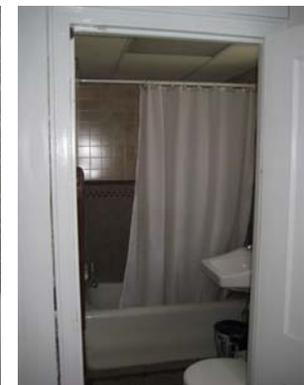
### Laundry Room Bathroom

This space is and has been in a state of disrepair.

The wall requires repair adjacent to the toilet. Wall and floor tile should be replaced.

Fixtures and plumbing should be replaced in their entirety.

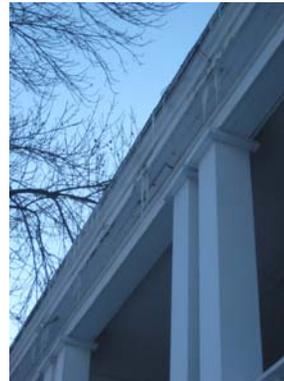
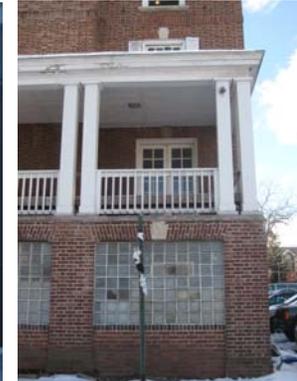
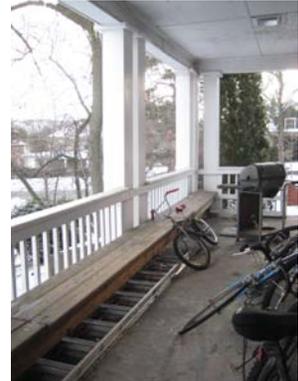
The side porch wood frame structure appears to be in reasonable condition. We did not access the roof of the porch on this visit so the roofing material conditions unknown.

The concrete porch floor is in poor condition. The edge is eroding and there is obvious water penetration to the lintels below. These are thus rusting, failing and crushing the glass block below. This system should be repaired immediately or risk further damage.

The porch steps are rotted and combined with the failing concrete create a safety concern. This should be repaired immediately.
