Case Study 1 – Residential House Remediation

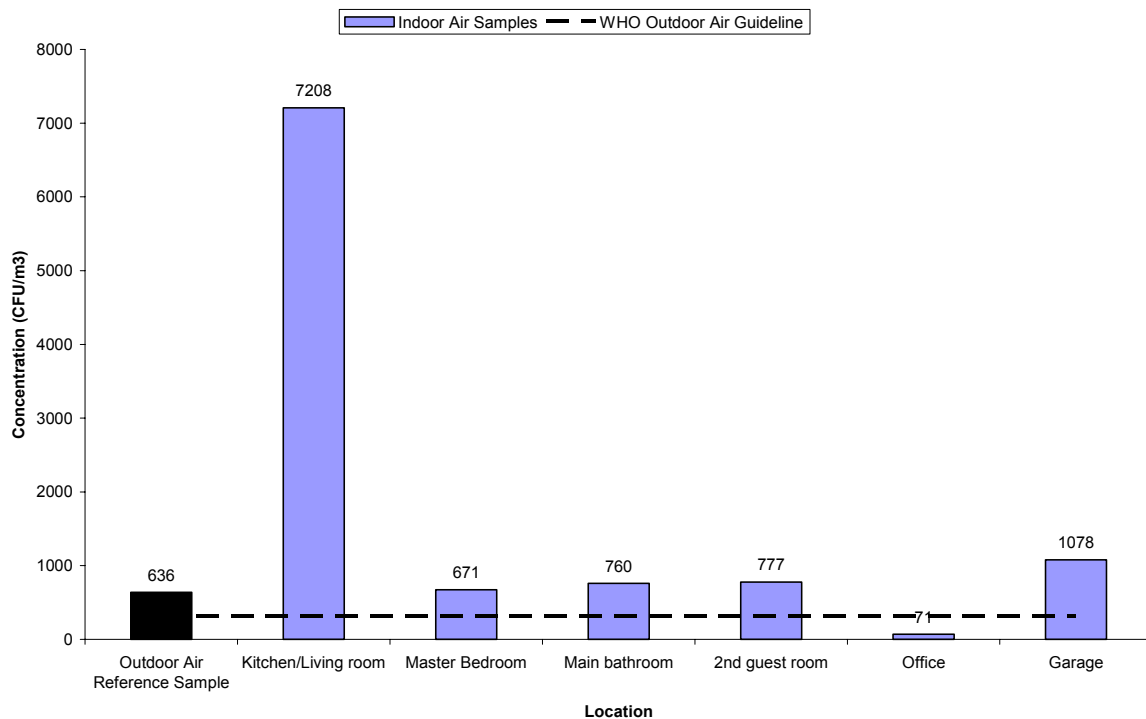
- Extremely high airborne fungal levels in kitchen, living room and garage area
- Extremely high surface fungal levels on documents, rugs and timber games unit
- Wet walls and concrete slab around premises due to water intrusion

Figure 1 Airborne Fungal Concentration: Pre-remediation

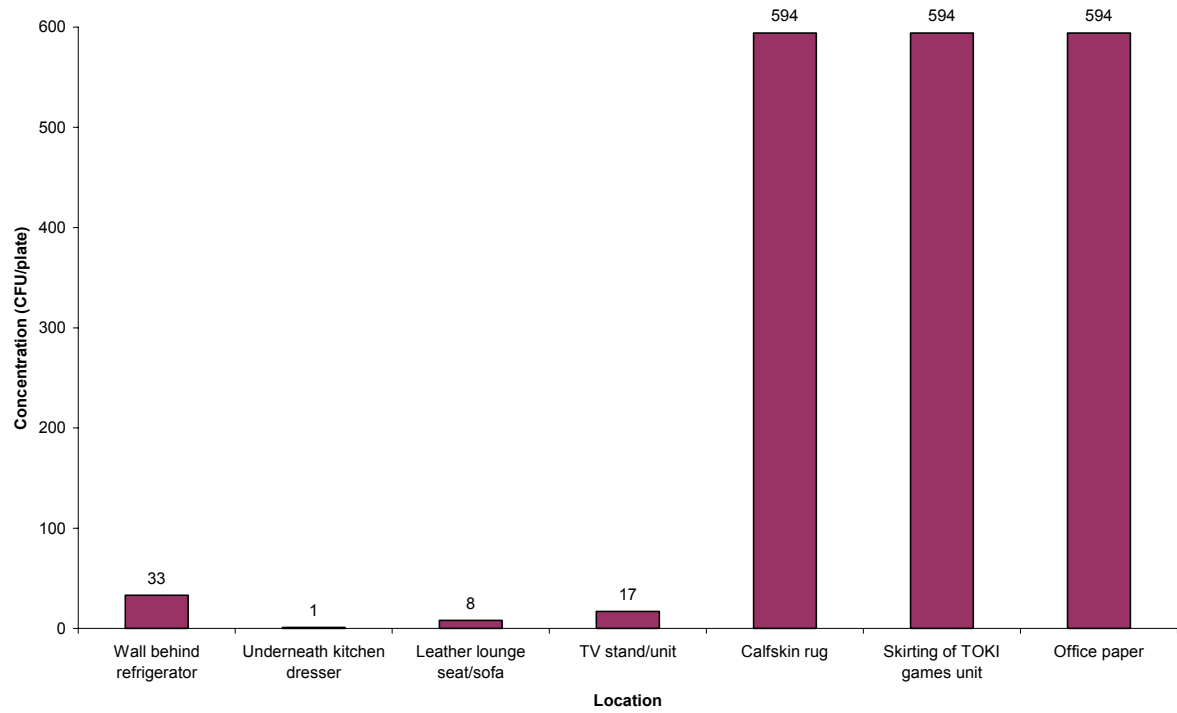
Figure 2 Surface Fungal Concentration: Pre-Remediation

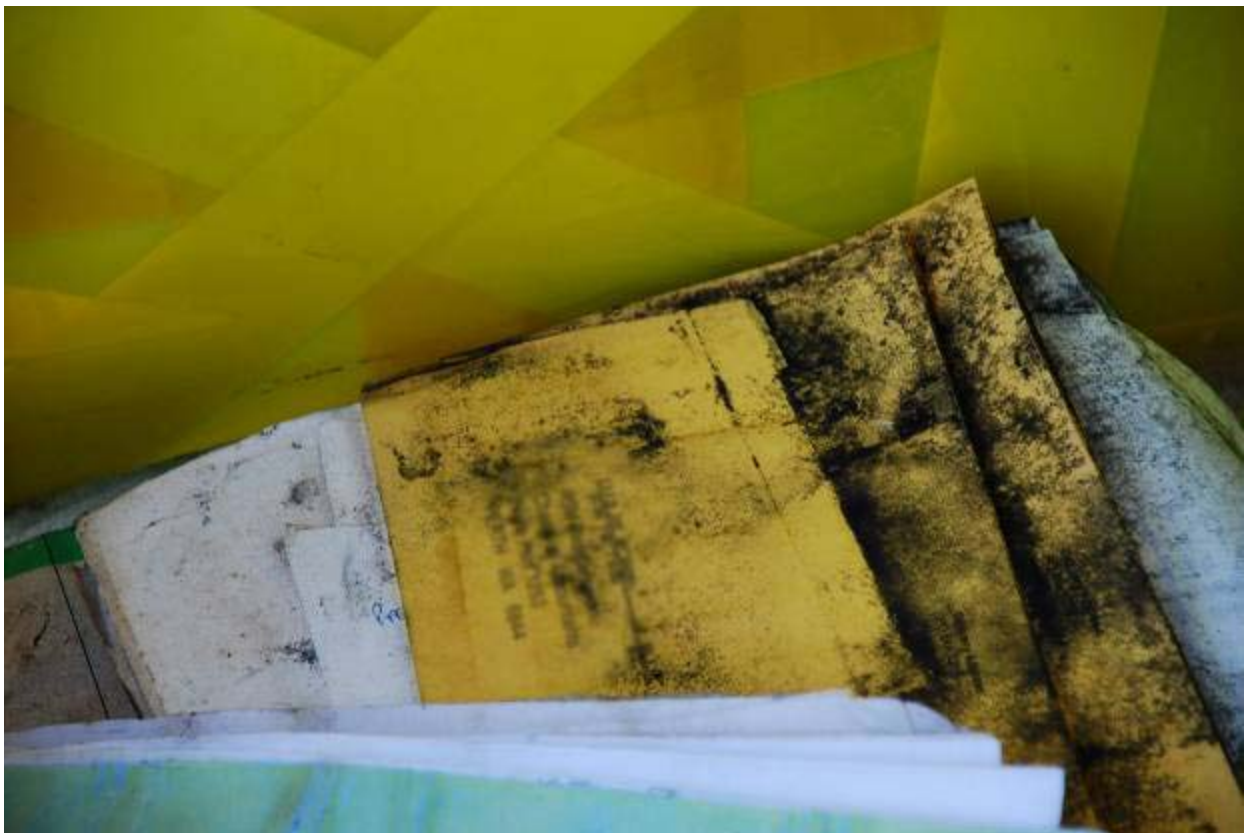
Figure 3 Mould contaminated documents

- Structurally dry walls and floors
- Pack out and remediation of contents
- Remediation (HEPA vacuum and damp wipe with micro-fibre & mould cleaning solution) of all surfaces (walls, ceilings, floors)

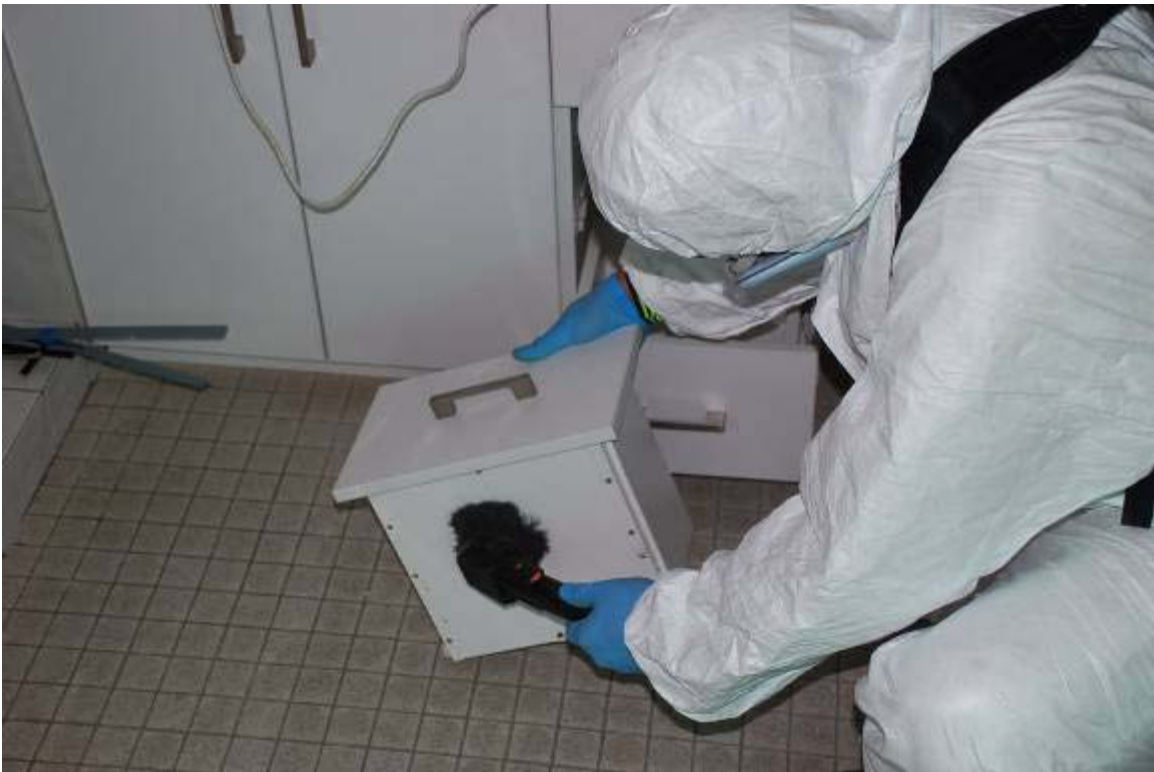
Figure 5 HEPA vacuuming of surfaces

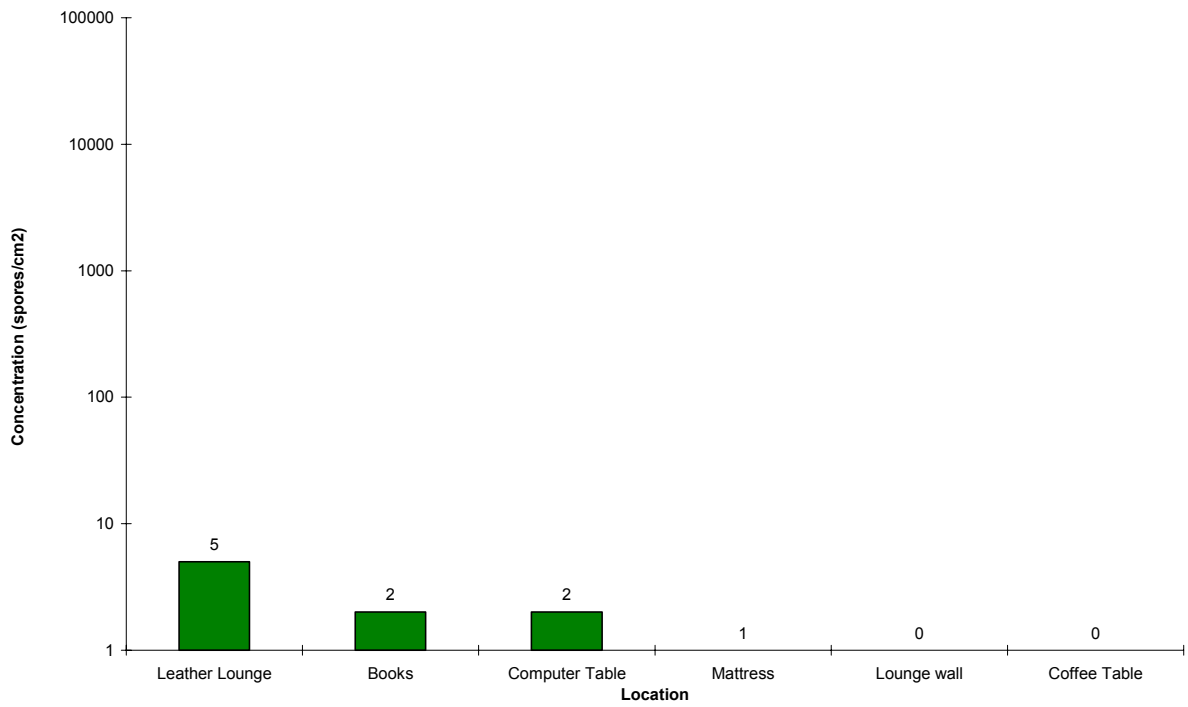
- Low airborne and surface fungal levels

Figure 7 Surface Fungal Concentrations: Post-remediation

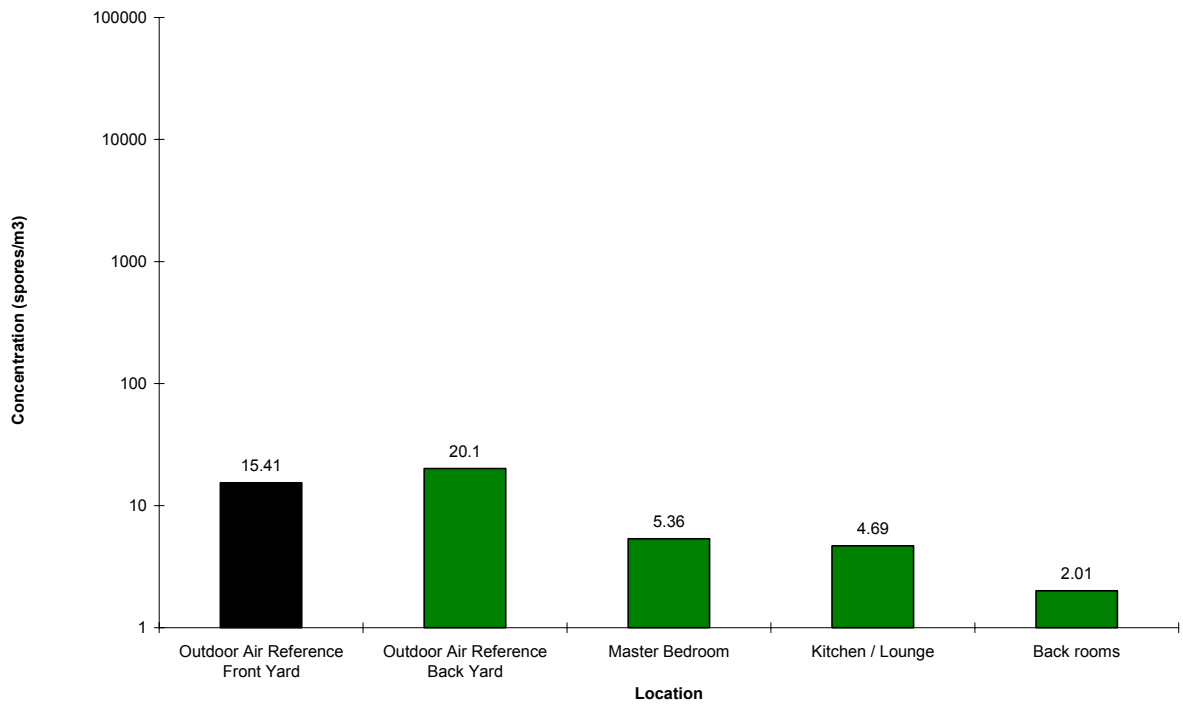
Figure 8 Airborne Fungal Concentrations: Post-remediation
