Case Study 1 – Residential House Remediation

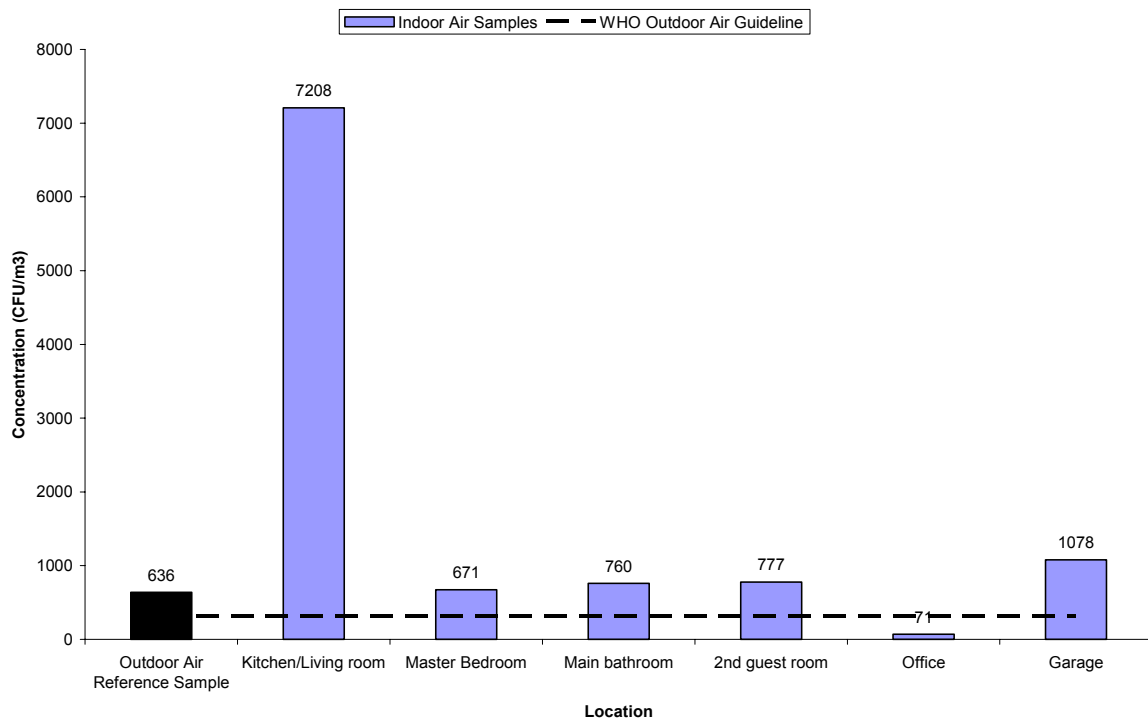
- Extremely high airborne fungal levels in kitchen, living room and garage area
- Extremely high surface fungal levels on documents, rugs and timber games unit
- Wet walls and concrete slab around premises due to water intrusion

Figure 1 Airborne Fungal Concentration: Pre-remediation

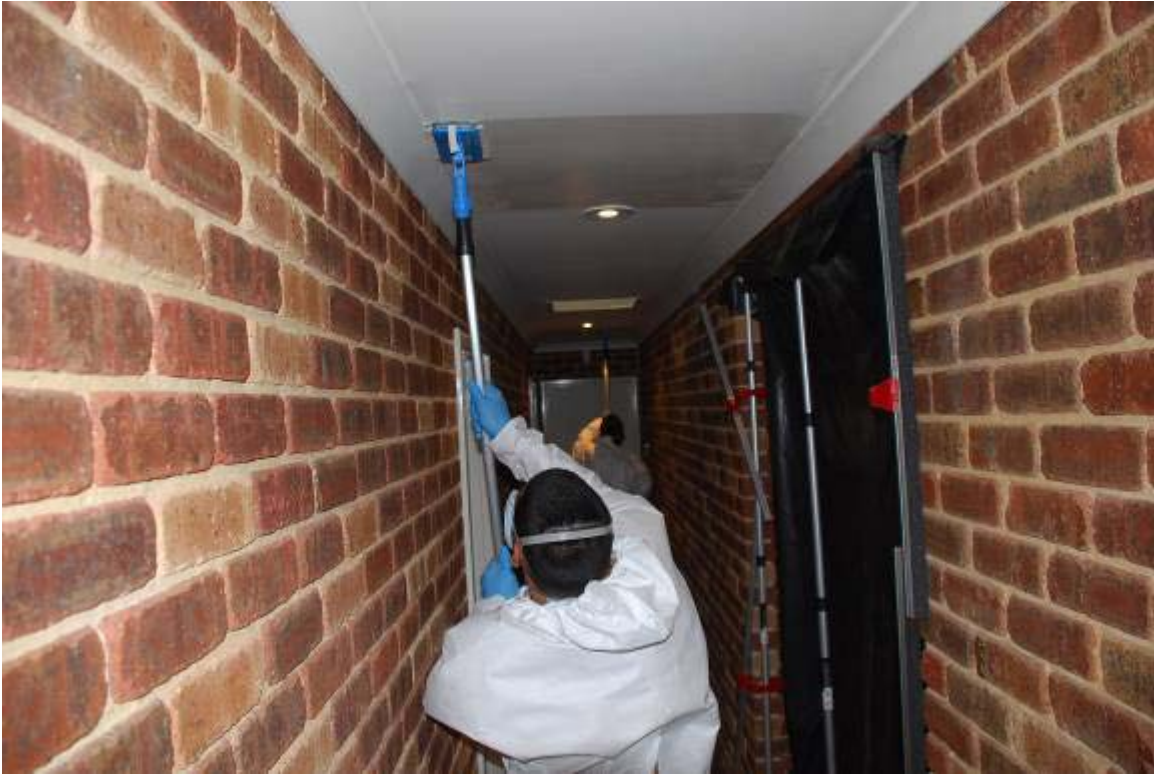
Figure 4 Remediation of ceilings with containment

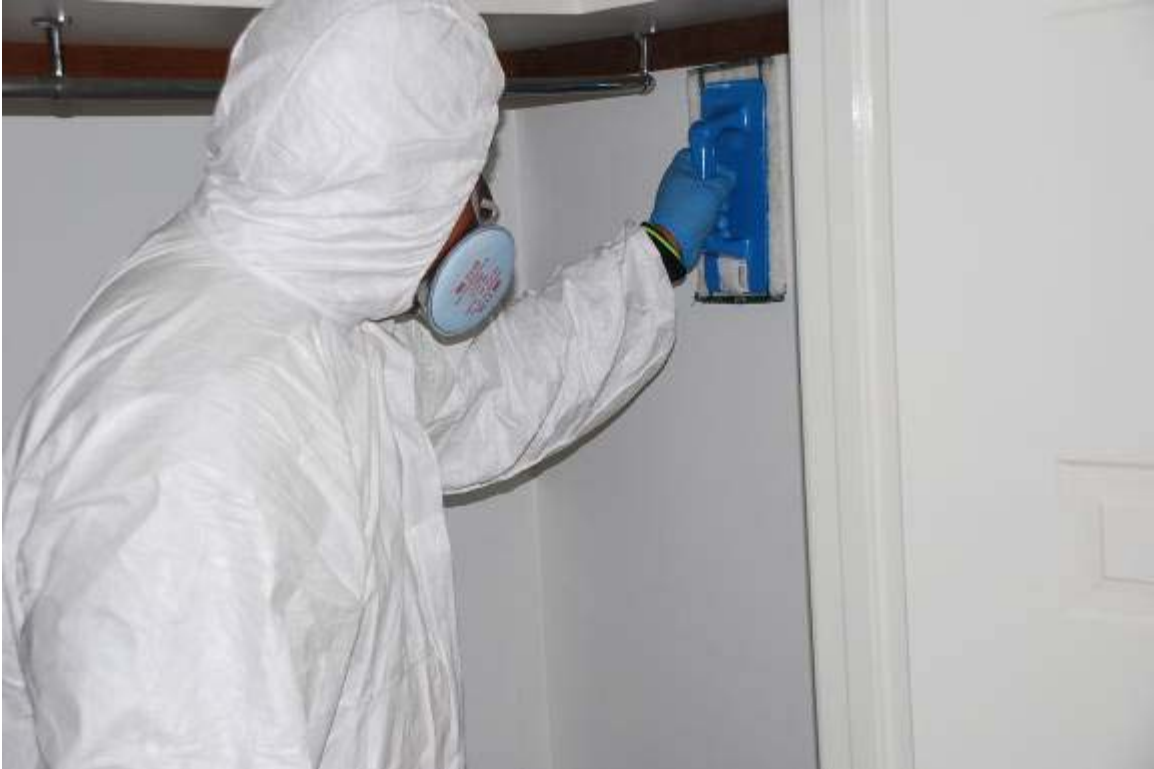
Figure 6 Damp wiping with micro-fibre cloth & mould cleaning solution

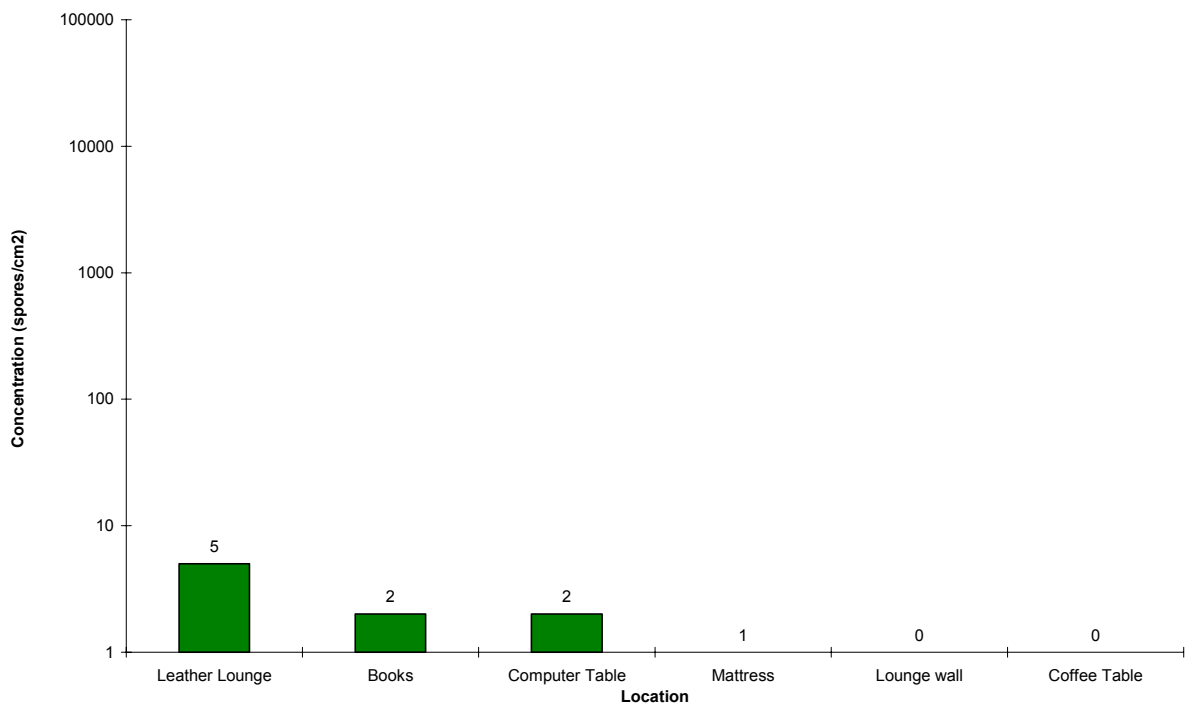
- Low airborne and surface fungal levels

Figure 7 Surface Fungal Concentrations: Post-remediation
