Case Study 4 – Split System Hygiene & Mould Remediation

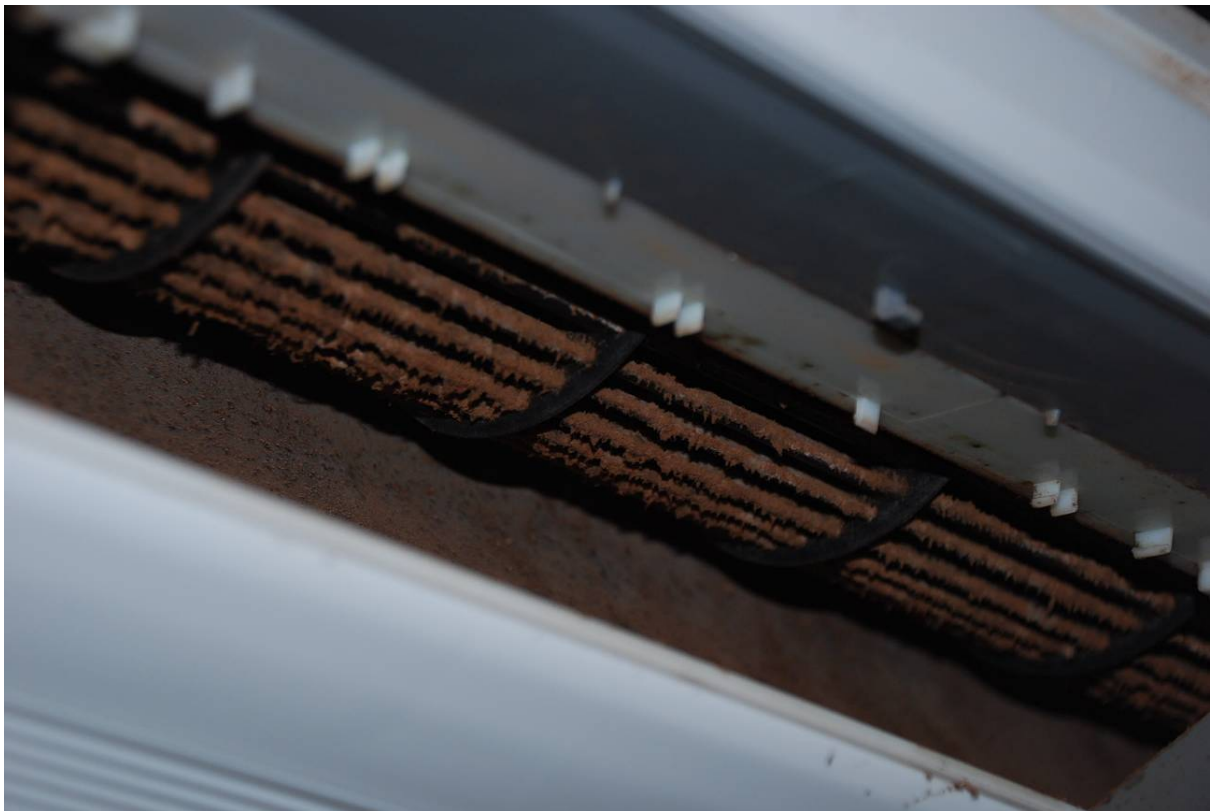
Figure 3 Fan blades prior to hygiene & mould cleaning

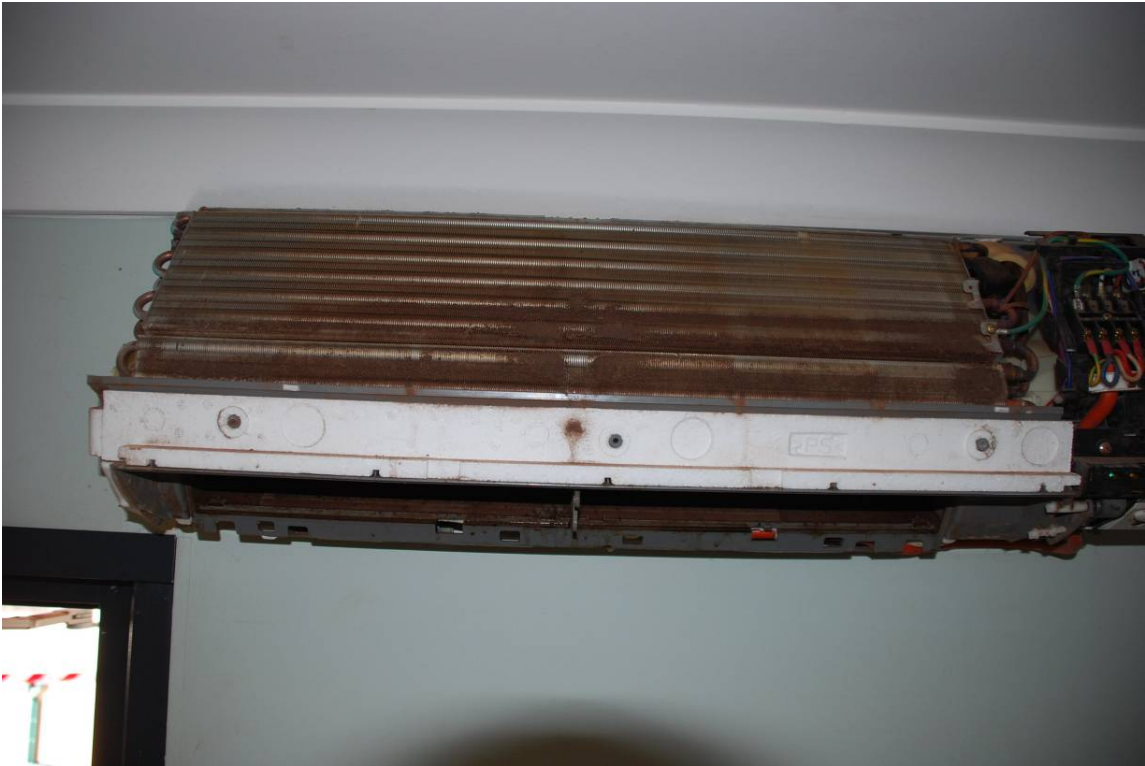
Figure 4 Cooling coils prior to hygiene & mould cleaning

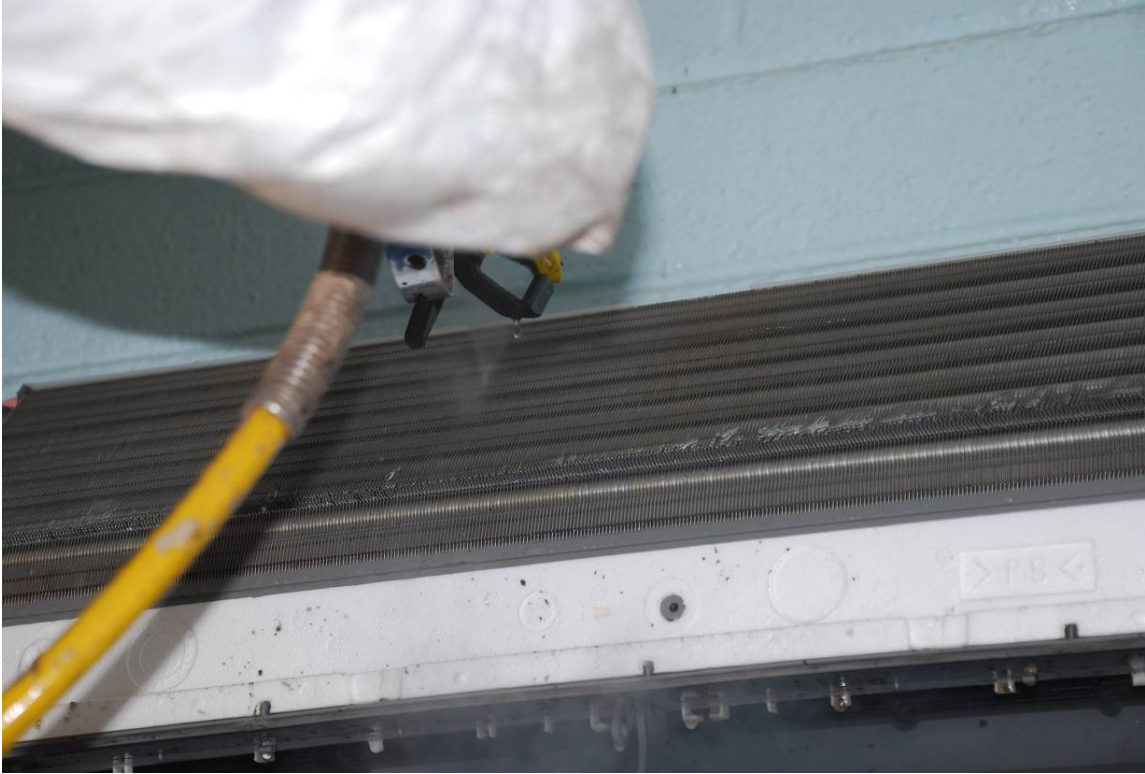
Figure 6 Remediation of cooling coils on split system HVAC

- Hygienic cleaning and mould remediation of split system AC including coils, fan blades, fins, barrel and caulging
- Clearance testing after all works completed

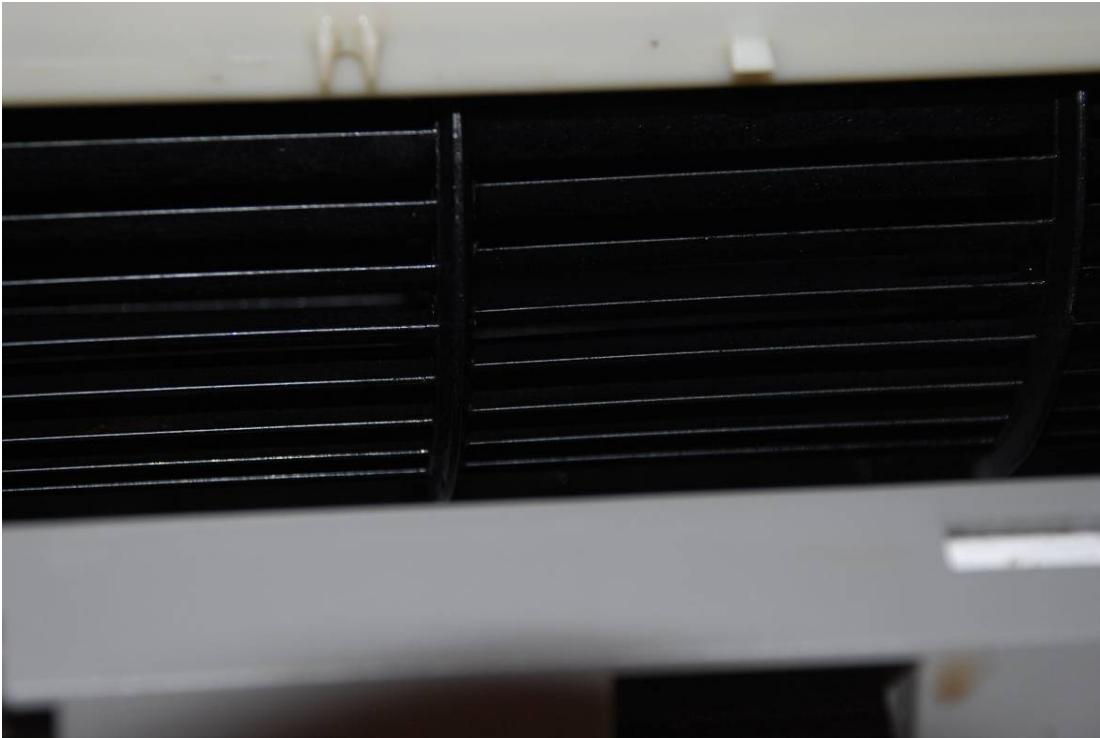
Figure 7 Fan blades after hygiene & mould remediation

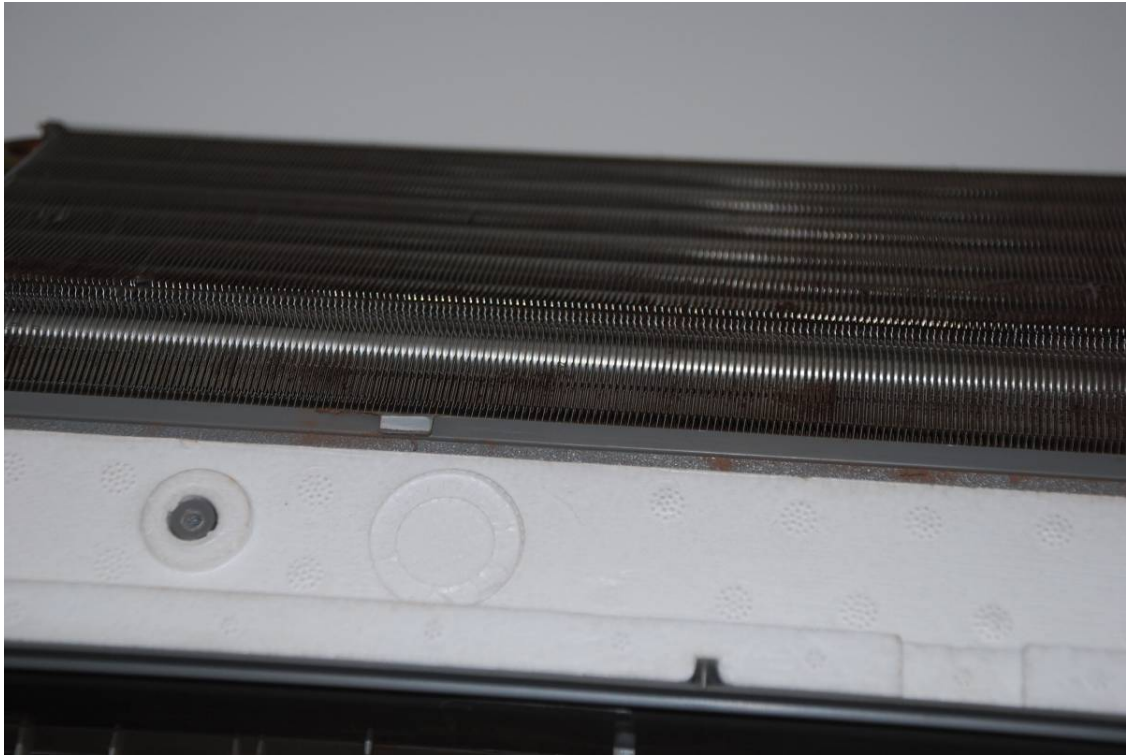
Figure 8 Cooling coils after hygiene & mould cleaning
