Case Study 5 – Ducted HVAC System Hygiene & Mould Remediation

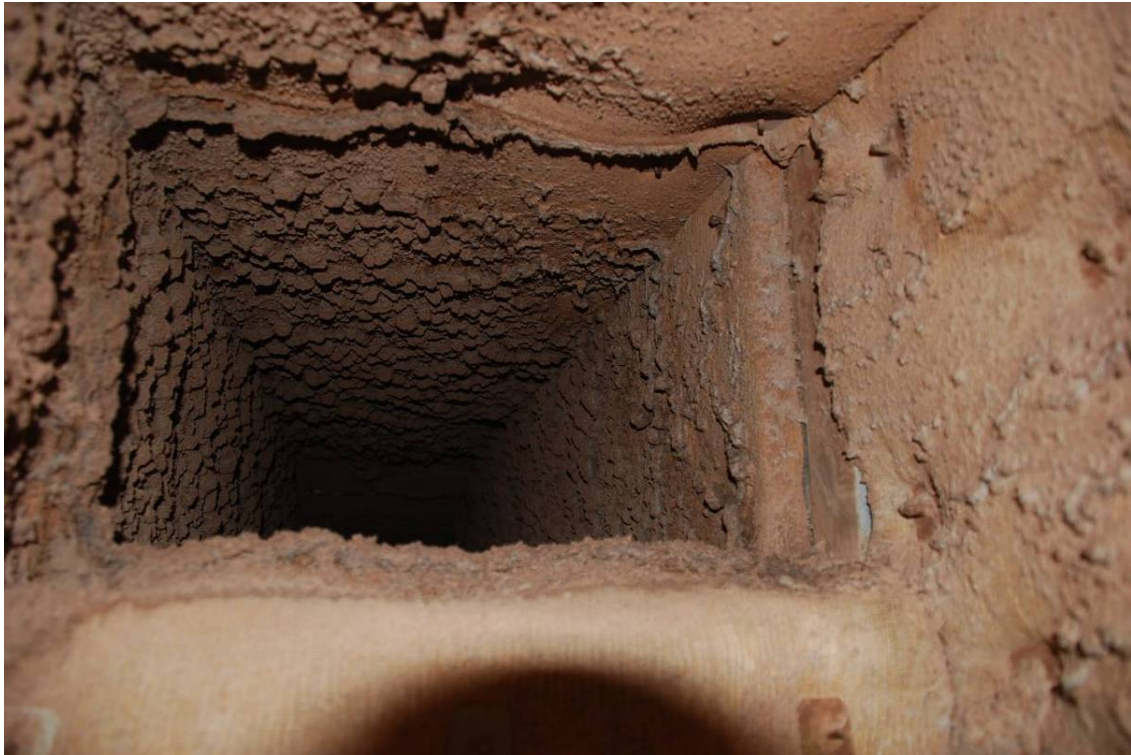
Figure 3 Ducting prior to HVAC hygiene & mould remediation

- Hygienic cleaning and mould remediation of ducted HVAC system including registers, cooling coils, ducts
- Clearance testing after all works completed

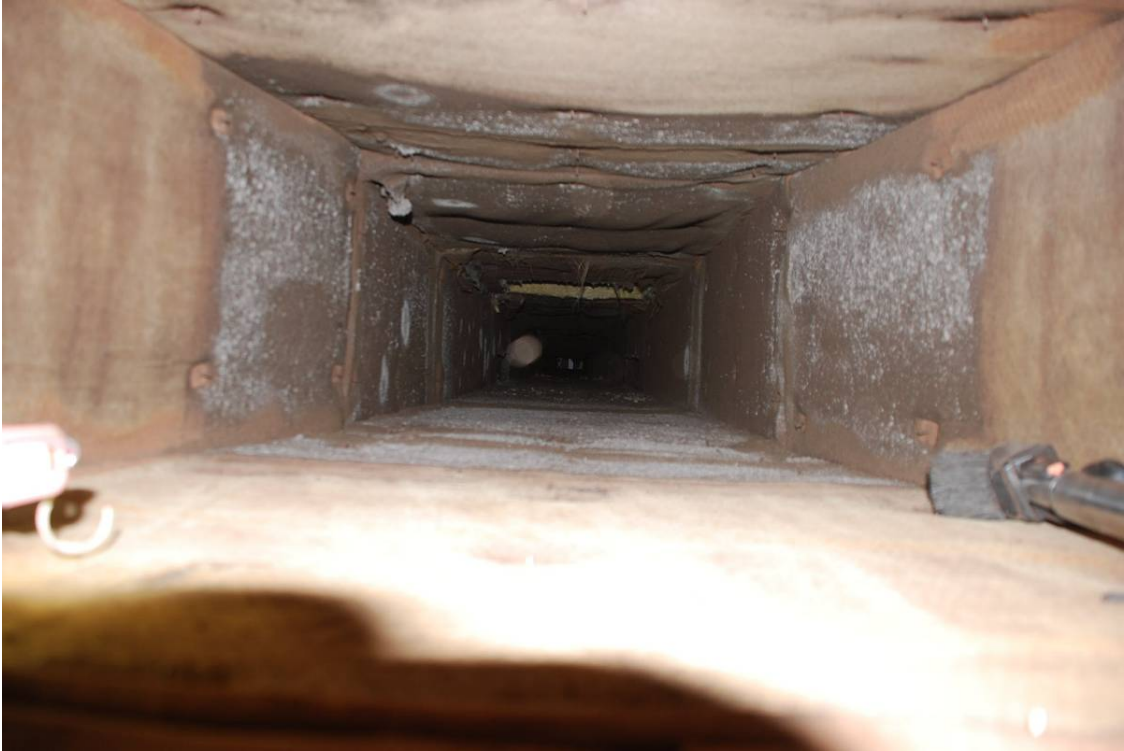
Figure 6 HEPA vacuuming of surfaces inside ducts

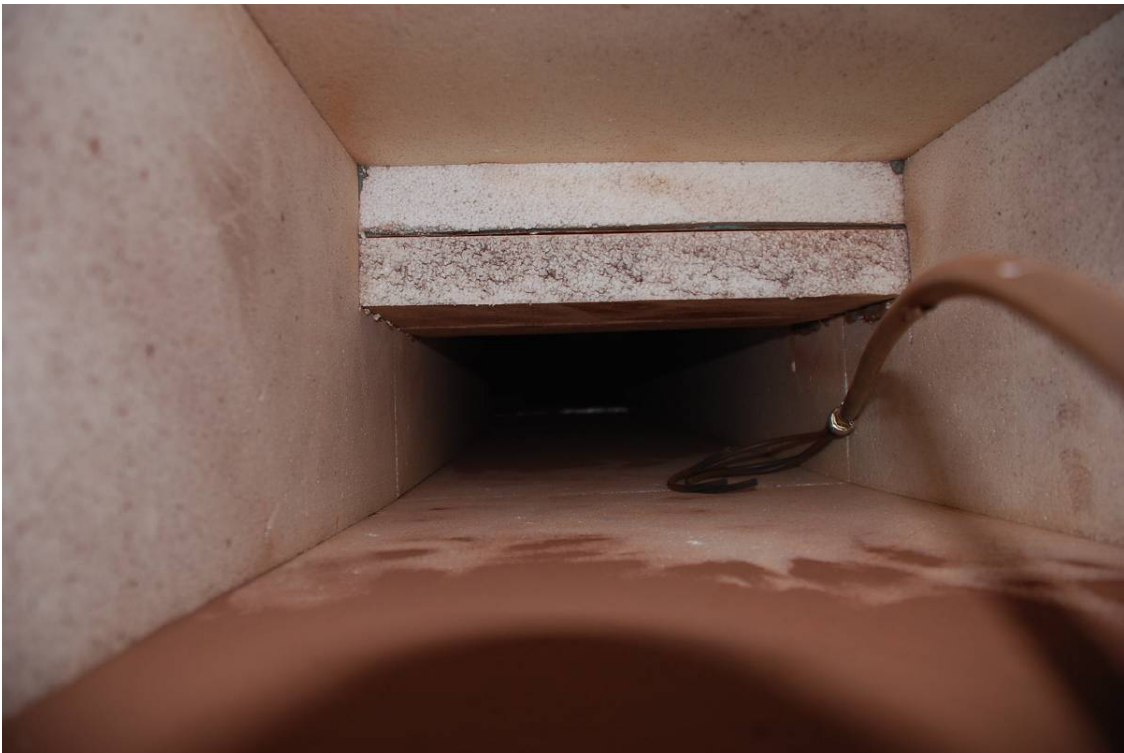
Figure 7 Duct cleaning using whip & compressed air

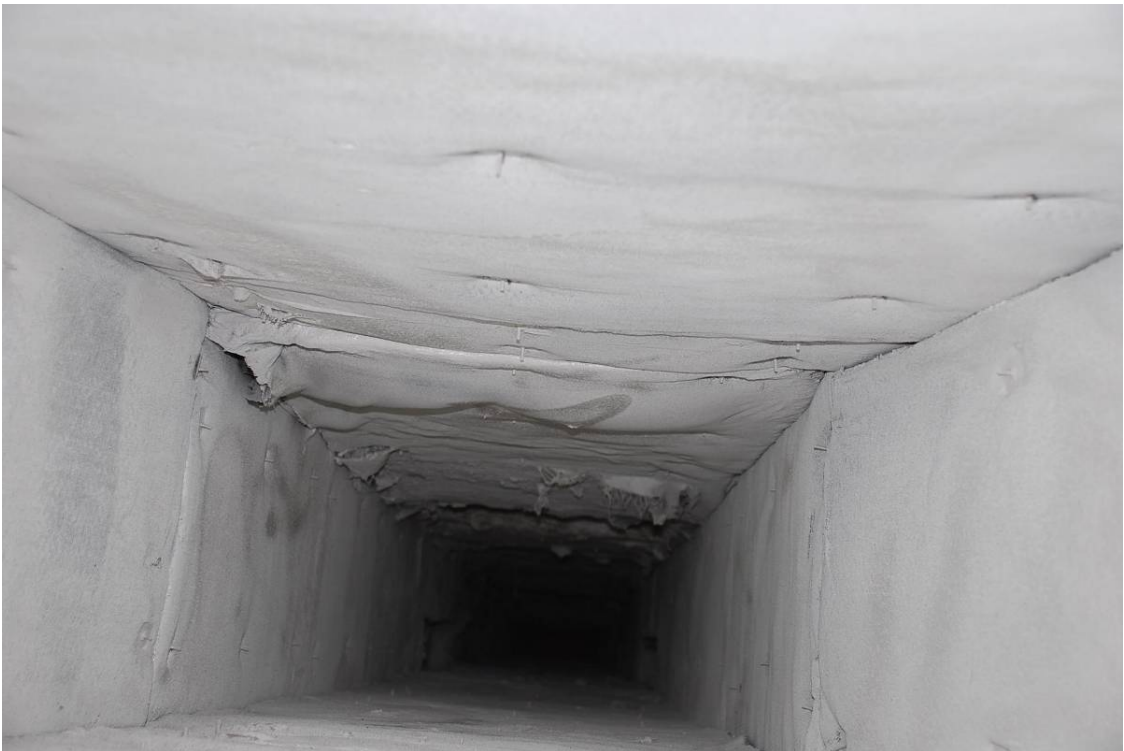
Figure 11 Encapsulation of ducting
