Case Study 5 – Ducted HVAC System Hygiene & Mould Remediation

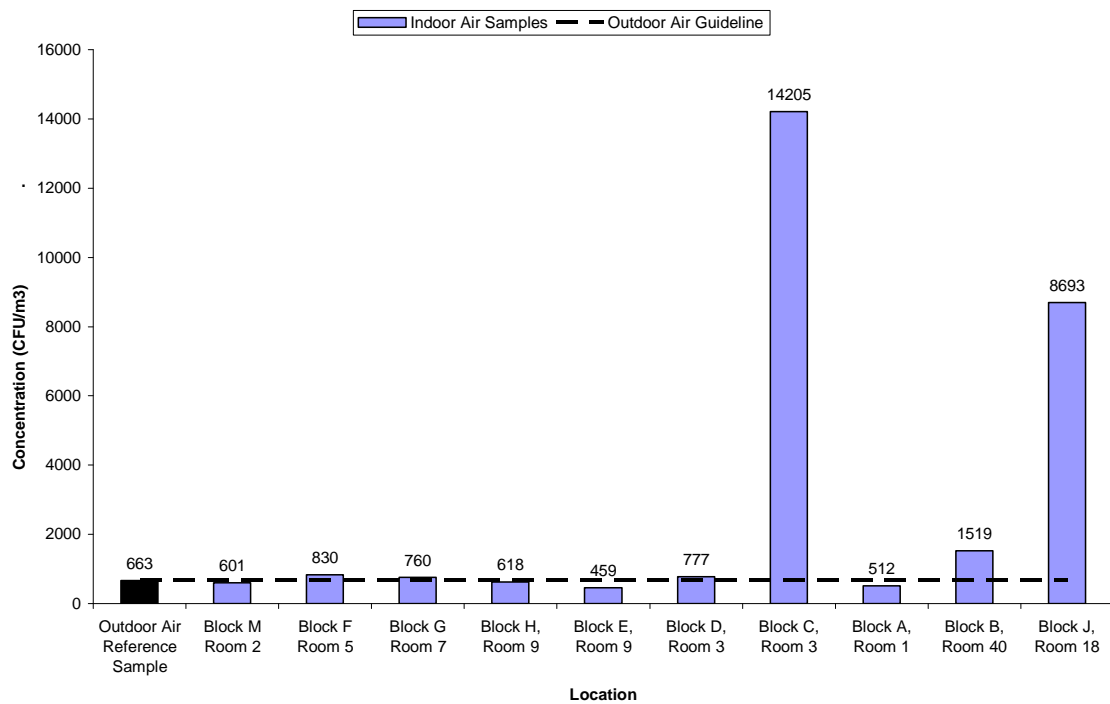
Figure 1 Airborne Fungal Concentration: Pre-remediation

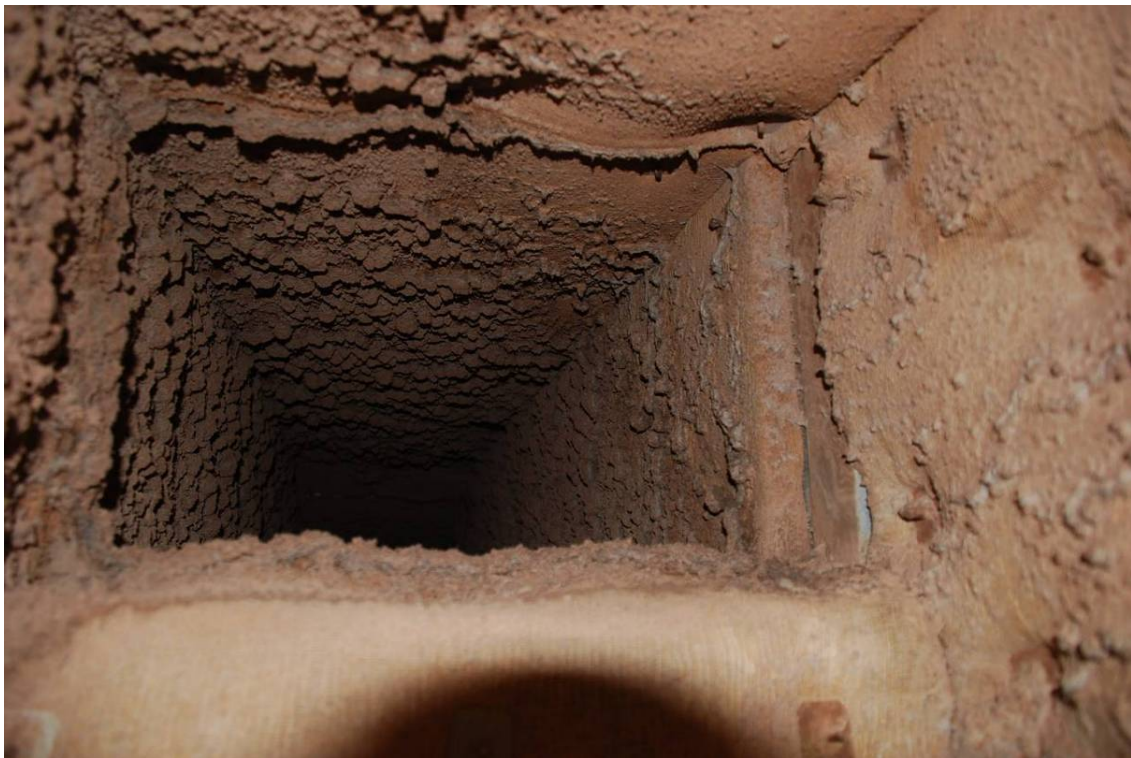
Figure 3 Ducting prior to HVAC hygiene & mould remediation

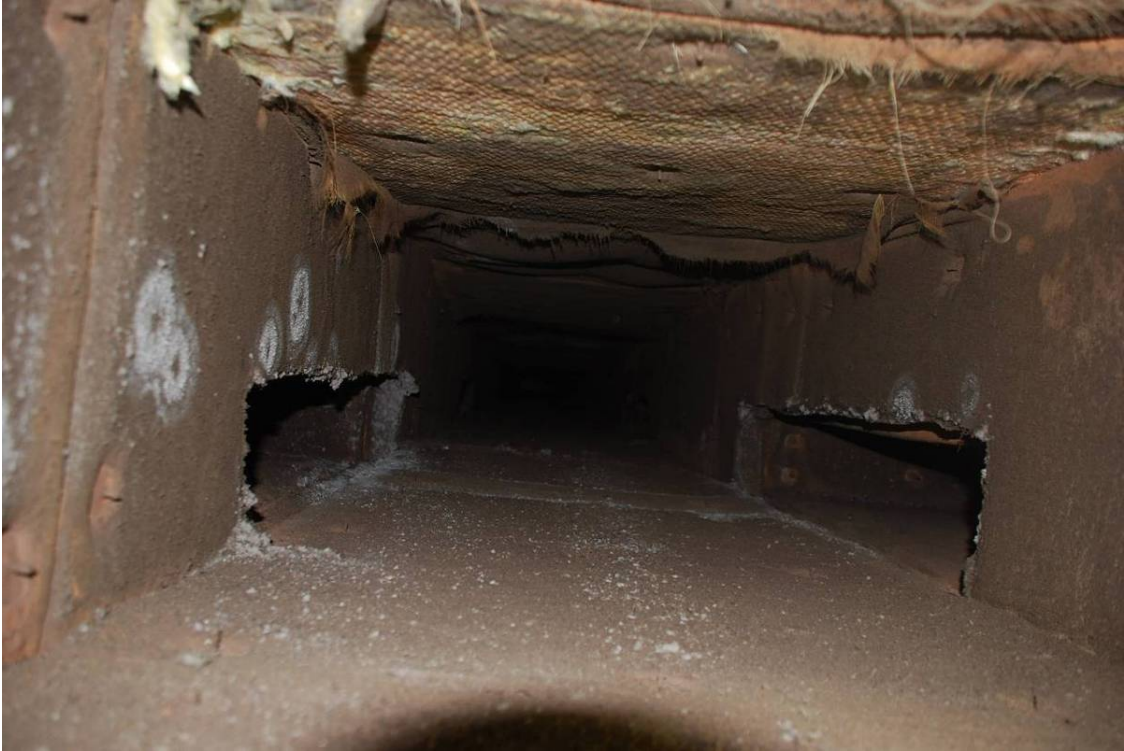
Figure 4 Ducting prior to HVAC hygiene & mould remediation

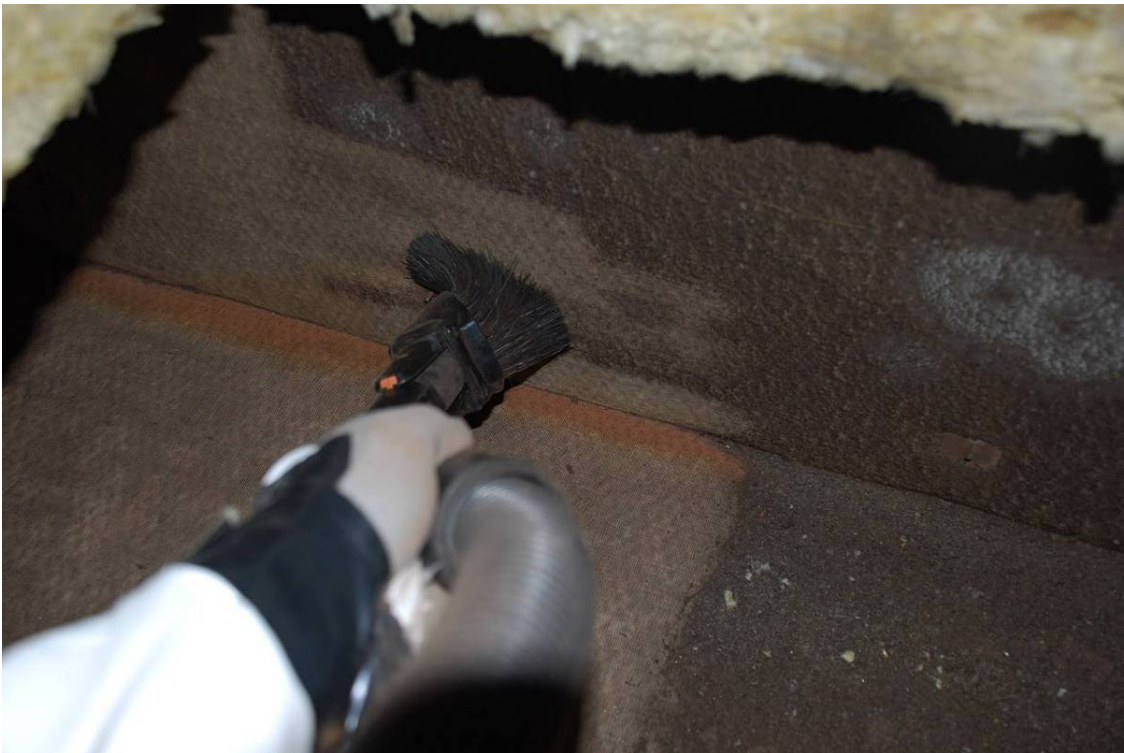
Figure 5 Contact cleaning inside ducts

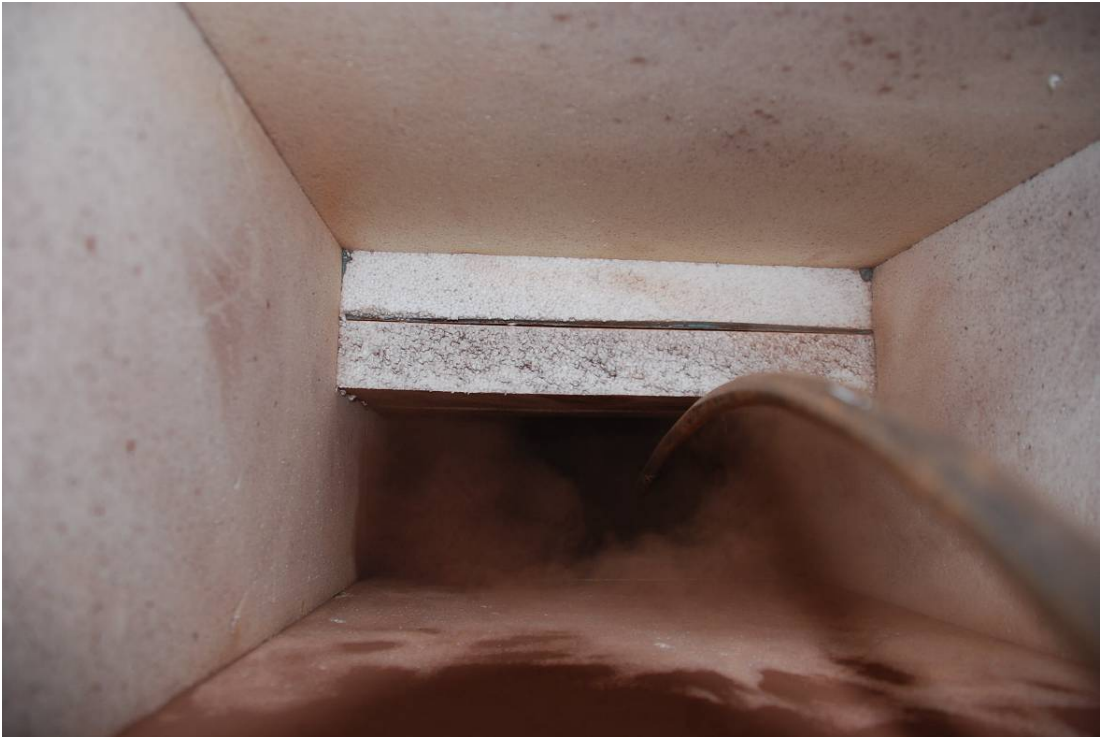
Figure 8 Duct cleaning using whip & compressed air

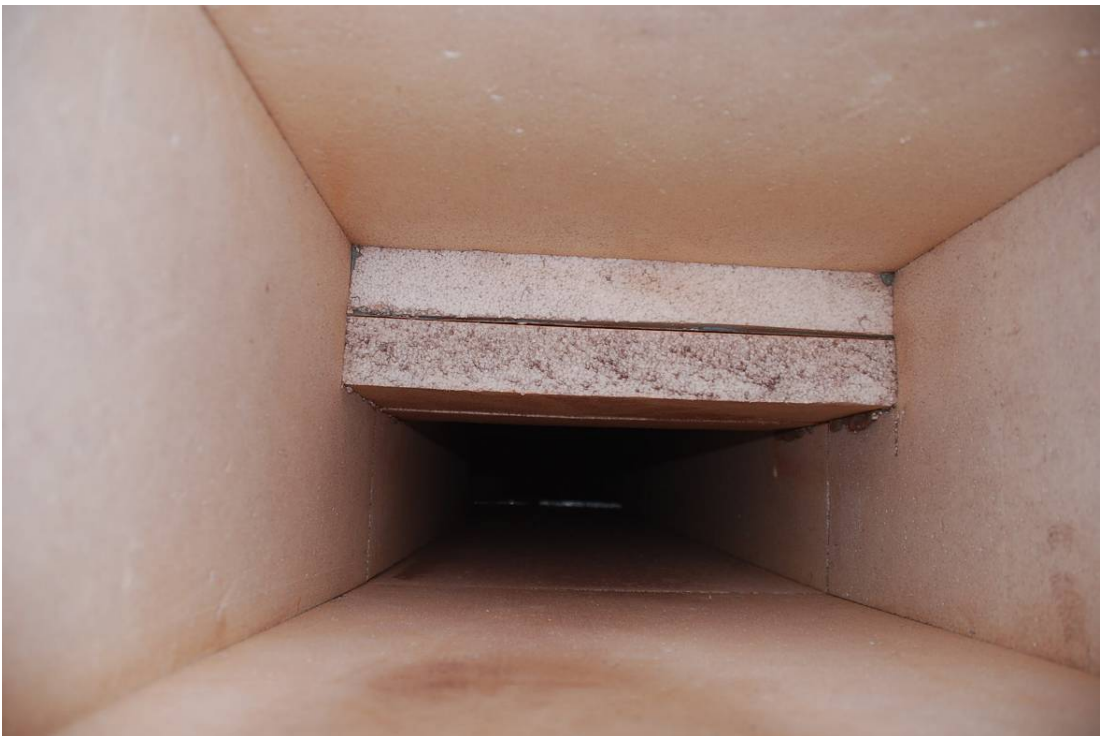
Figure 9 Duct cleaning using whip & compressed air

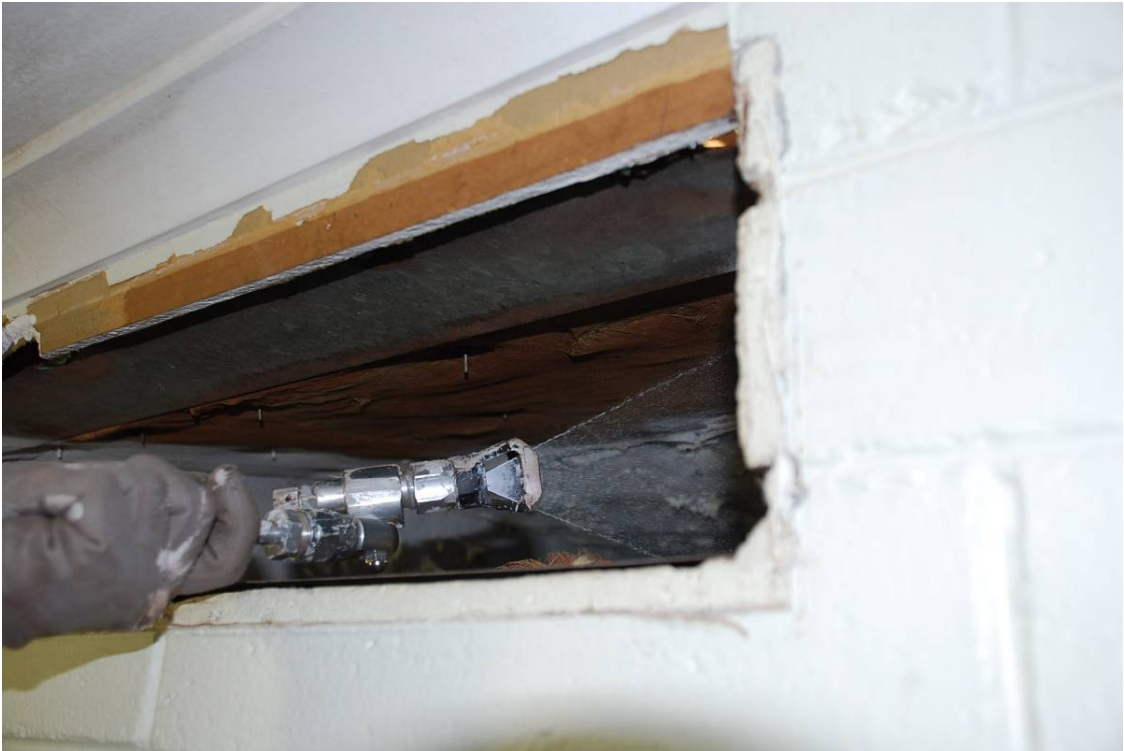
Figure 10 Encapsulating process
