Unidentified Harbor Wreck  
*Royal Navy Dockyard, Bermuda*

**Report of Fieldwork  
December 2007**

Nathan Richards  
Joseph C. Hoyt  
*Program in Maritime Studies  
East Carolina University  
Greenville, North Carolina, USA*

*Report to the  
Government of Bermuda &  
Bermuda Maritime Museum  
February 2008*

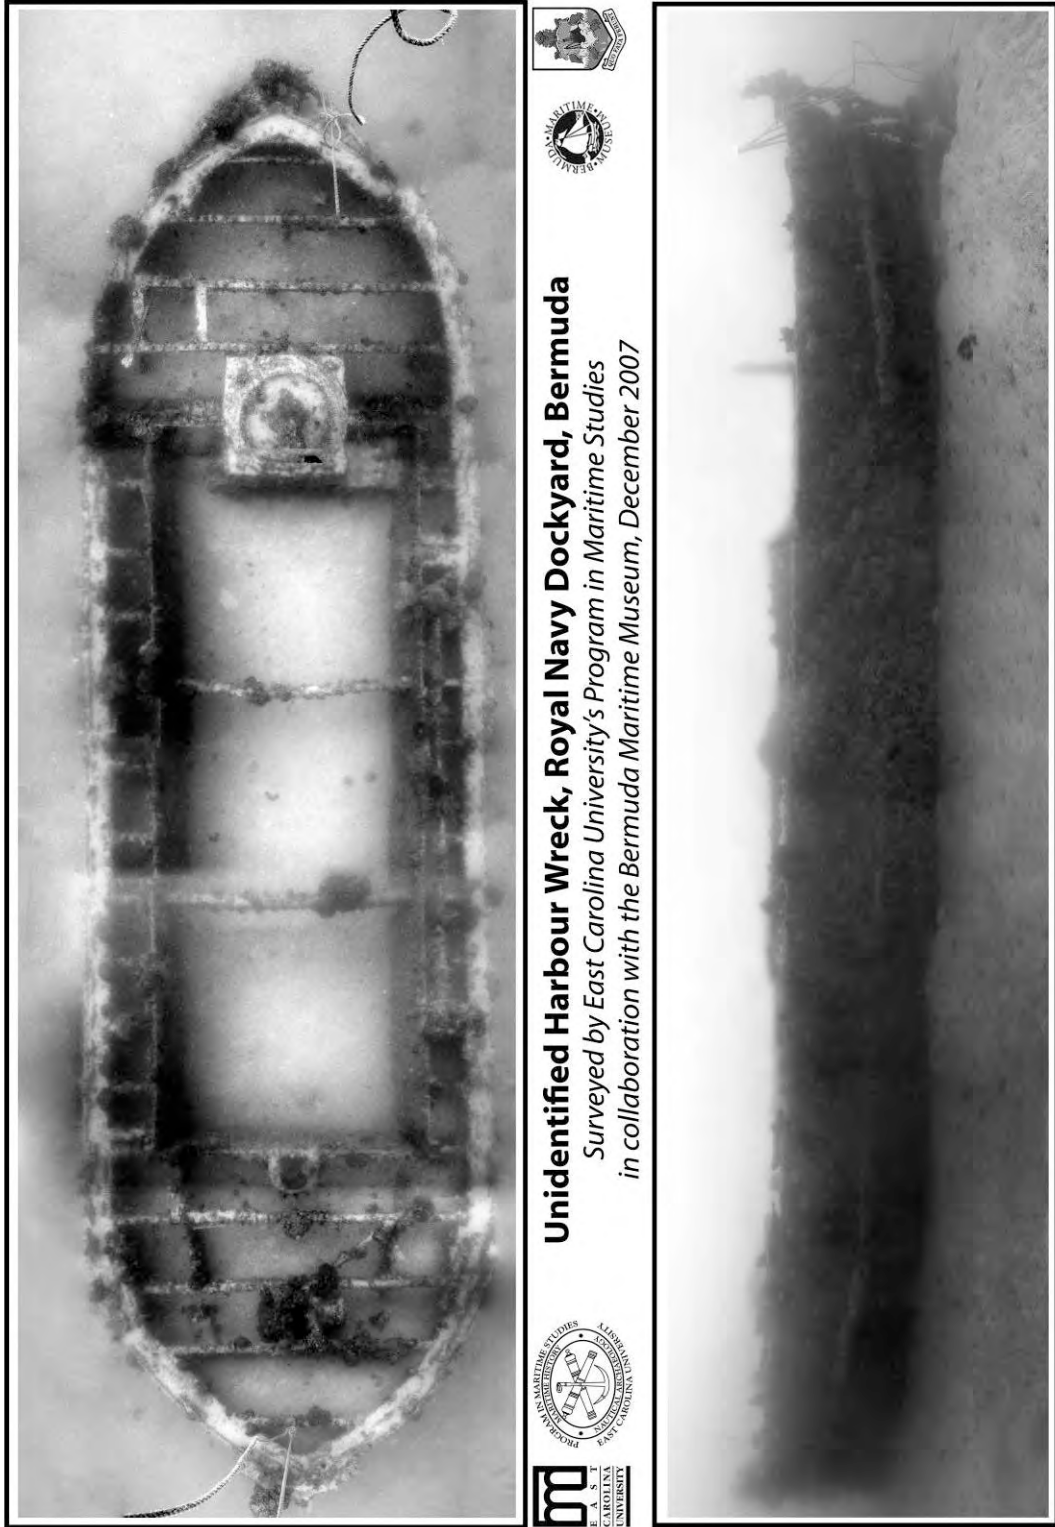
*Photomosaic:* In conjunction with photographic documentation, the archaeologist successfully created a detailed photo-mosaic of the site (Figure 3). The success of this operation was wholly dependent upon water clarity. Due to water visibility in excess of 25 feet (7.62 m), a photomosaic in plan, and profile (portside) view was completed before the date of departure (18 December 2008) and is now in a digital archive at the BMM (as a layered \*.psd file as well as in high-resolution raster file (\*.pdf, \*.tif and \*.jpg) formats. Upon return to North Carolina this photomosaic was printed as a high-resolution black and white poster in a 36" x 45" format and accompanies this report. There were no restrictions on the nature of photomosaic photography, although the best shots were those taken where the degree of parallelism between camera lens and subject were optimal. Additionally, there was no need to complete a photographic log for the photomosaic, and shots did not require the inclusion of a scale bar. The photomosaics (plan and profile) were achieved with the use of Adobe Photoshop CS2 and its autostitch function.

**Figure 3.** Plan and profile (port) photomosaic of the unidentified harbour wrecksite, Royal Navy Dockyard, Bermuda (Photo: J.Hoyt, 15 December 2007).

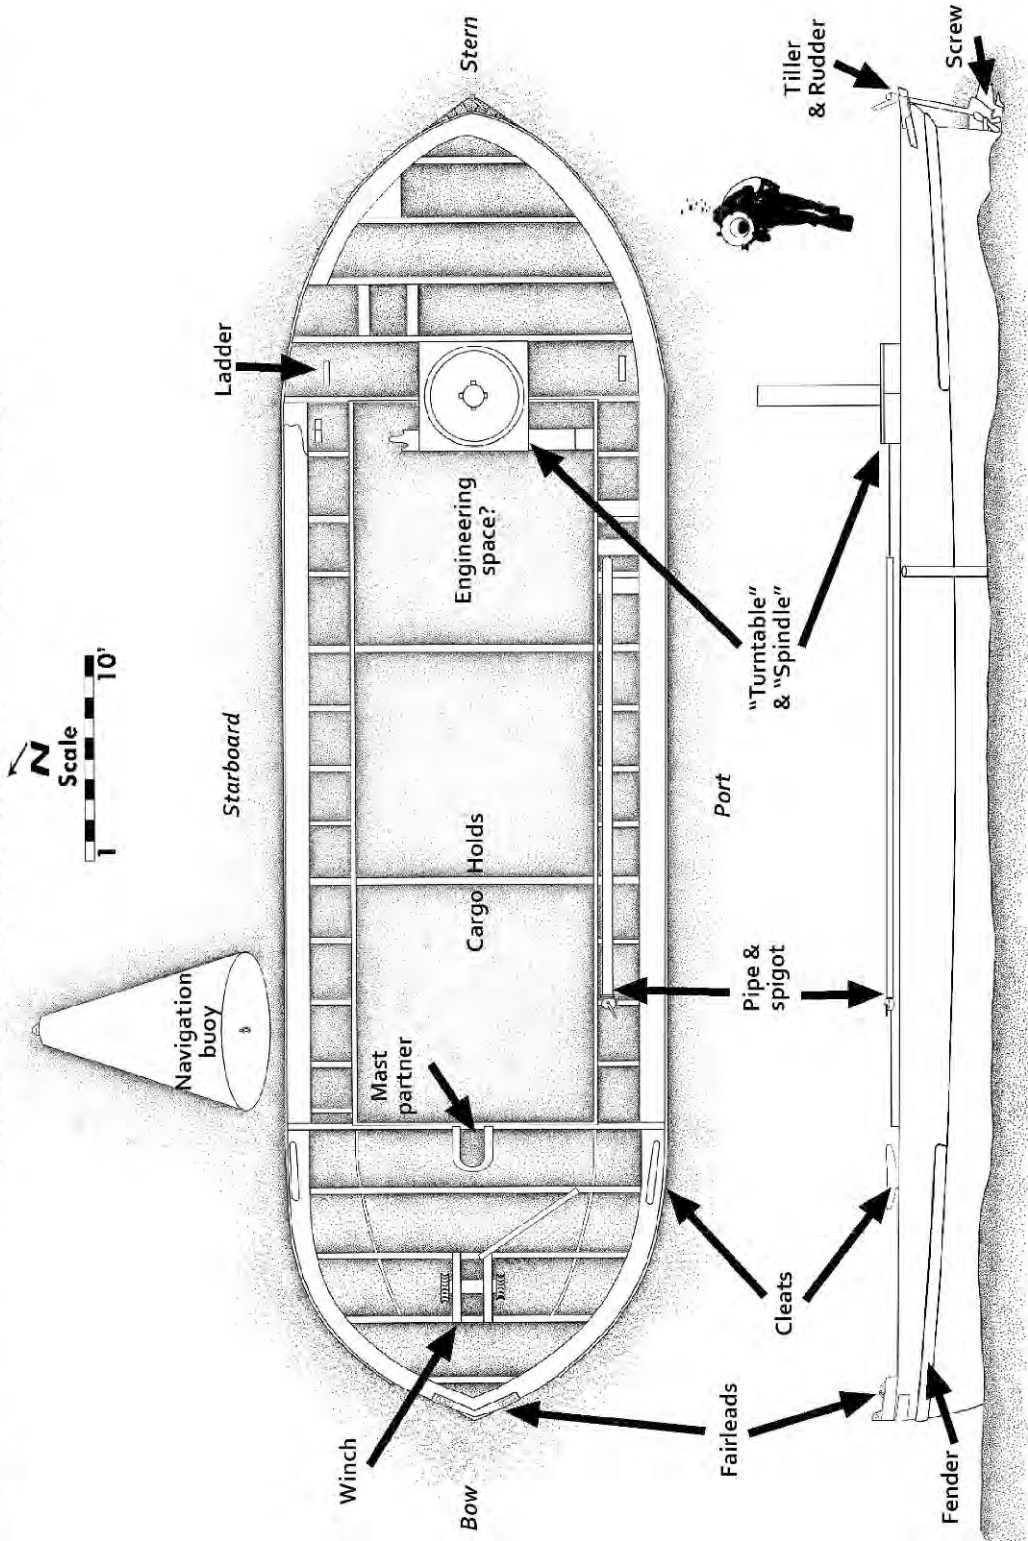
Figure 5. Plan and profile drawing of the unidentified harbour wreck (Drawing, N. Richards, J. Hoyt and B. Rodgers, 2007)

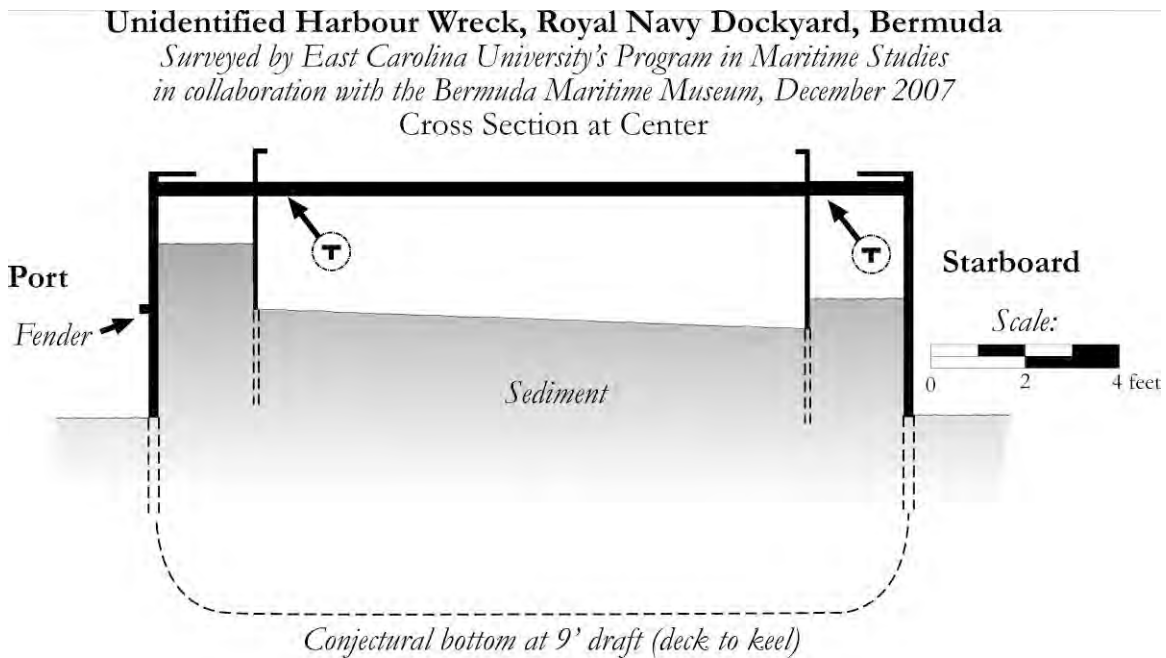
*Cross-section (athwartships):* A cross sectional view was created by measuring vertical and horizontal distances across the ships' beam. From these measurements, a depiction of the exposed structure, volume of sediment and conjectural outline of buried remains could be made (Figure 6).

**Figure 6.** Cross section of the unidentified harbor wreck (Drawing by N. Richards)

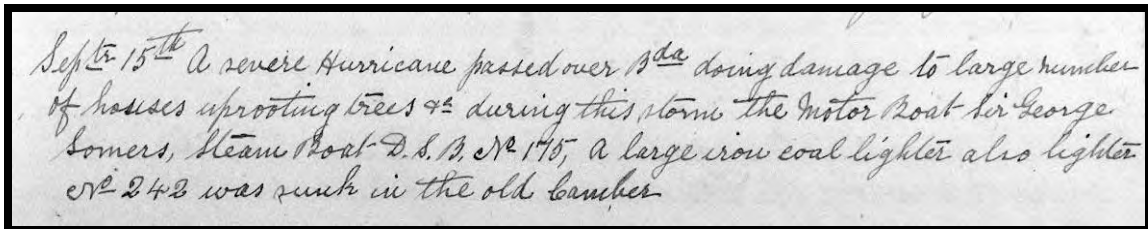
Figure 36. Extract from Barritt Diary (Bermuda Maritime Museum).

There is some potential for identification of the unidentified harbor wreck site. A notation on page 204 of the diary of Benjamin Barritt between 1891 and 1949 (in possession of the Bermuda Maritime Museum) dated to September 15, 1921 notes the following (see also Figure 36):

Sept 15<sup>th</sup> A severe hurricane passed over Bda [Bermuda] doing damage to large number of houses uprooting trees & during this storm the motor Boat Sir George Somers, Steam Boat D.S.B. No 175, a large iron coal lighter also lighter No 242 was sunk in the old Camber.

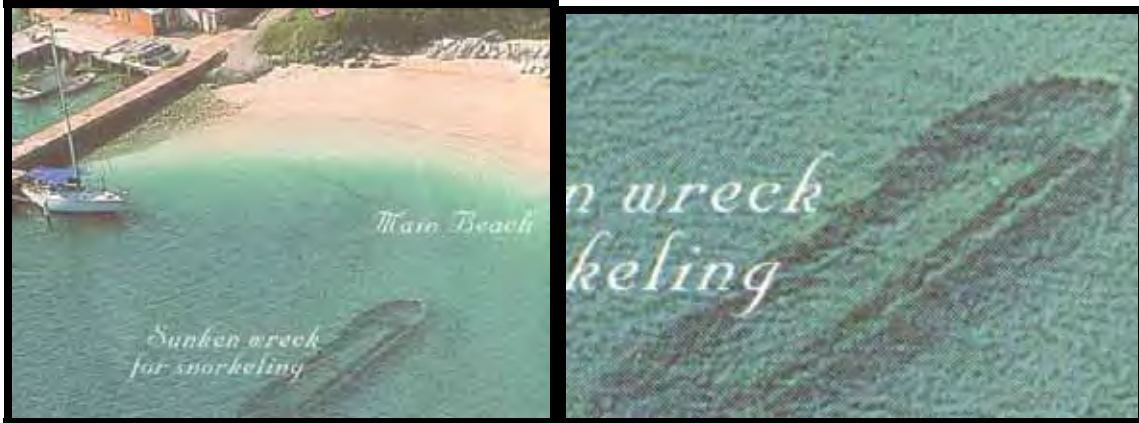
In an additional quirk of fate, upon departing from Bermuda the archaeological personnel were delayed at the airport and were housed at the Grotto Bay Beach Resort near St. Georges. Upon being given their pamphlet "A one minute tour of Grotto Bay Beach" crew members noticed the text "sunken wreck for snorkeling" printed on the inside (see Figure 37). The wreck appears to be about the same size, and of similar configuration (a squat vessel of rounded ends and open hatches amidships) as the other two vessels. This adds to a hypothesis that there was a class of steam lighters in operation in the coastal areas of Bermuda. Given the propensity for vessels to be taken to St. Georges for stripping, salvage and/or abandonment this may be a sister ship to the vessels potentially identified as DSB No.175 and 242 in the vicinity of the Royal Navy Dockyard.

**Figure 37.** Portion of Grotto Bay Beach resort pamphlet (inside) showing two details of the shipwreck potentially related to the unidentified Dockyard site.
