REPORT OF MARINE SURVEY

CONDITION & VALUATION

1989 CARVER 3467 SANTEGO

M/V “ [REDACTED] ”

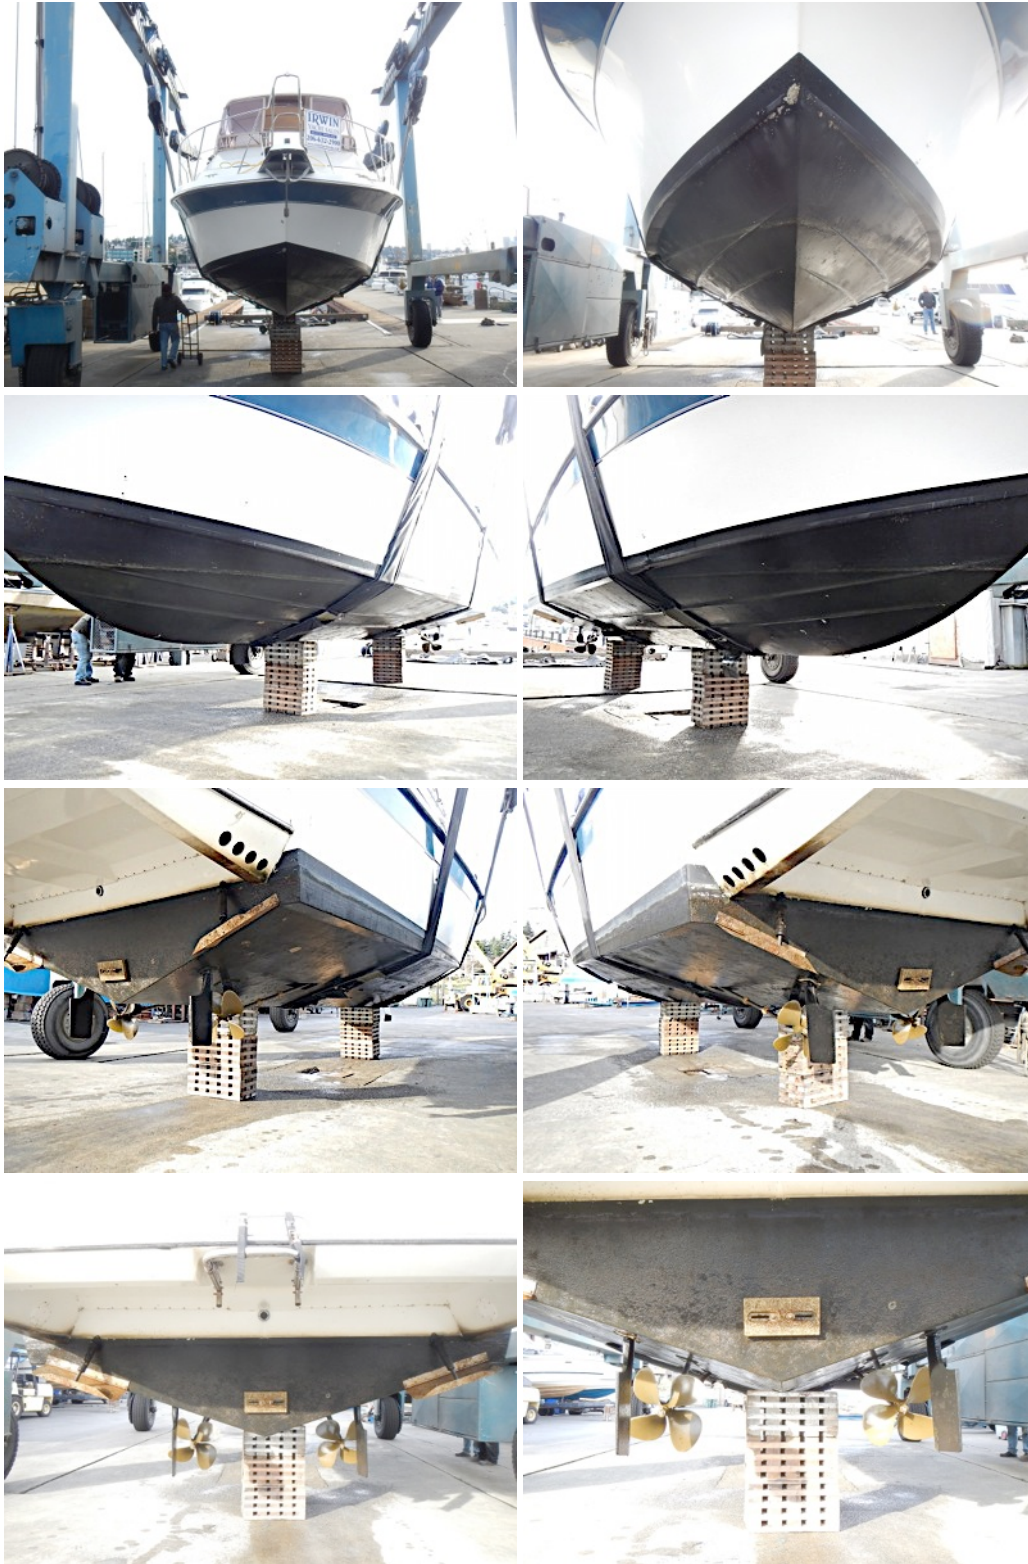
WETTED SURFACE AREA PHOTOS

- There were approximately 10 to 20 blisters sighted at the vessel's wetted surface area at time of haul-out inspection. Blisters sighted ranged in size from 1" diameter to 8" in diameter. Blisters were not lanced at time of inspection. Severity of blister penetration is undetermined. Recommend monitor quantity, size, location, and condition of blisters each time vessel is hauled out of the water, and service / repair blisters as required.
