# THETA CHI Fraternity

## Feasibility Study & Conditions Analysis

**THETA CHI of Penn State  
Omega Chapter  
523 South Allen Street  
State College, PA 16801**

**April 11, 2011**

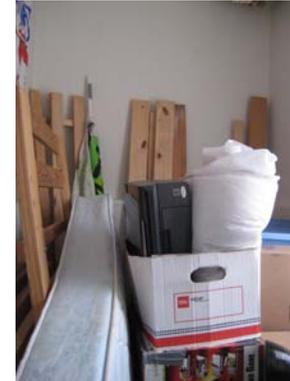
### First Floor Bedroom

This space is in good condition. There is an interest in converting a large closet contiguous to this space into an accessible bathroom and possibly creating an ADA compliant bedroom suite at this level.

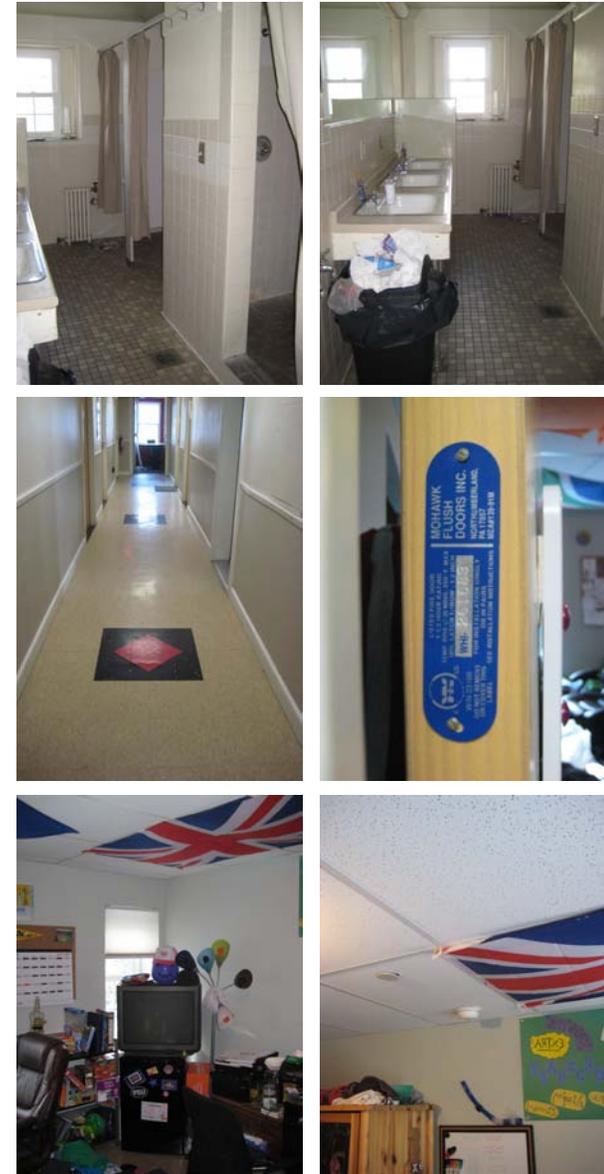
## THIRD FLOOR

The third floor was upgrade when the house was re-opened. In general the rooms on this floor are in good condition and require no further work.

The hallway ceiling is new acoustical ceiling tile system. This system is in good condition. The walls appear to have been furred out and skimmed with new drywall and then painted. All are in good condition.
