Service Bulletin

KV Series Vacuums Quick Disconnect Replacement Part #890630

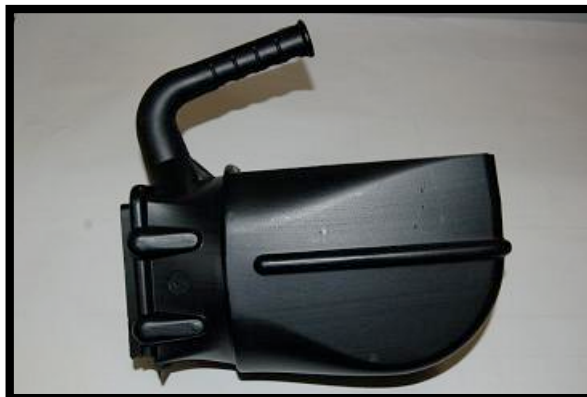
The replacement quick disconnect will look like the one in the photo below and is installed through the back of the bag as illustrated on the attached sheet. This should be a one-time replacement and is covered under warranty by submitting a claim through the normal channels for credit. The model and serial numbers are required on all claims or they will not be processed. This will not affect the KD series vacuum as they will use the 890176 Quick Disconnect and all of the KV units will use the new Part # 890630.

This Service Bulletin is to address the debris bag issue for the KV series vacuums that you may or may not be aware of. If you have any units that have not retailed your distributor needs a list of the model and serial numbers so they can send replacement parts to update these units right away. For retailed units, when a customer is having problems with premature wear on the bag, the dealer needs to order a new quick disconnect from their distributor which should alleviate the problem. Customers that have had multiple failures should be notified of this fix as soon as possible. A new bag may also be covered under warranty if a customer's bag shows signs of wear in the affected area. If the bag also needs to be replaced you can order kit part number 891202 which includes the new quick disconnect and a new bag.
